# Technical Memorandum

## Tremé Urban Flooding Investigation

Technical Memorandum

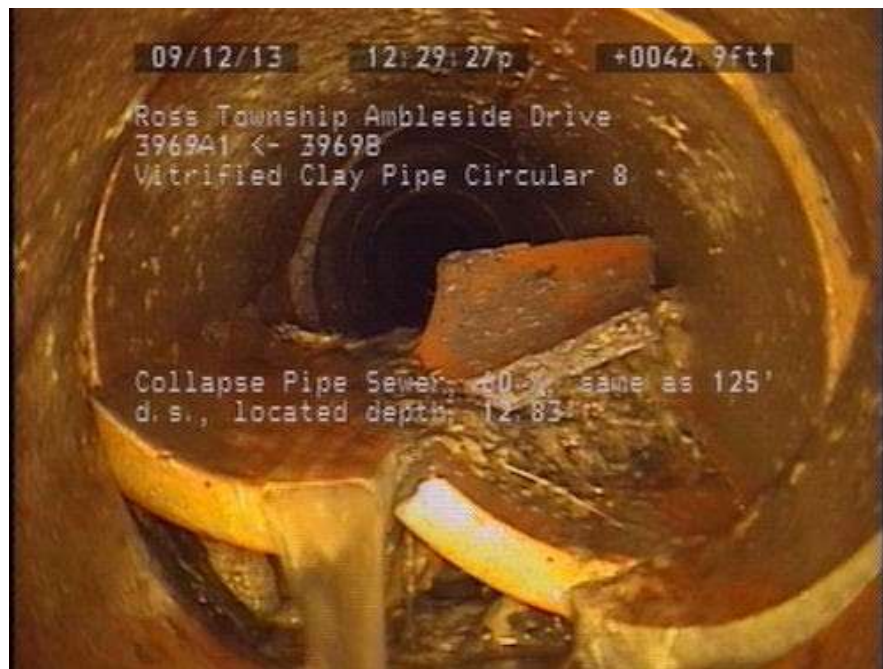
capacity of the drainage network but can also create conditions for sinkholes, surface flooding, and ongoing infrastructure deterioration.

Figure 8: Example of Broken Terracotta Drain Line

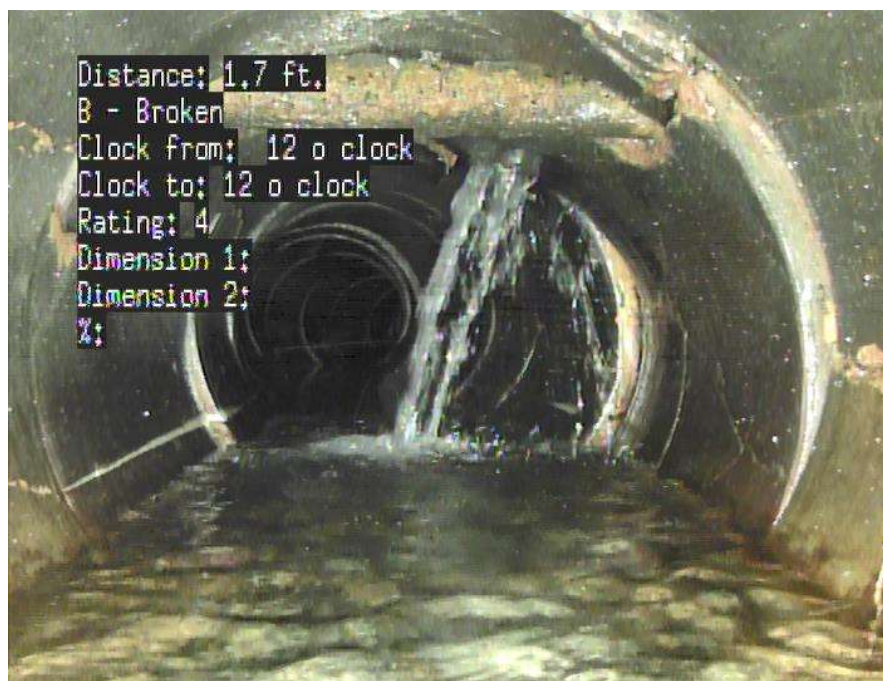
Figure 9: Example of Water Leak Intrusion to Drainage Pipe

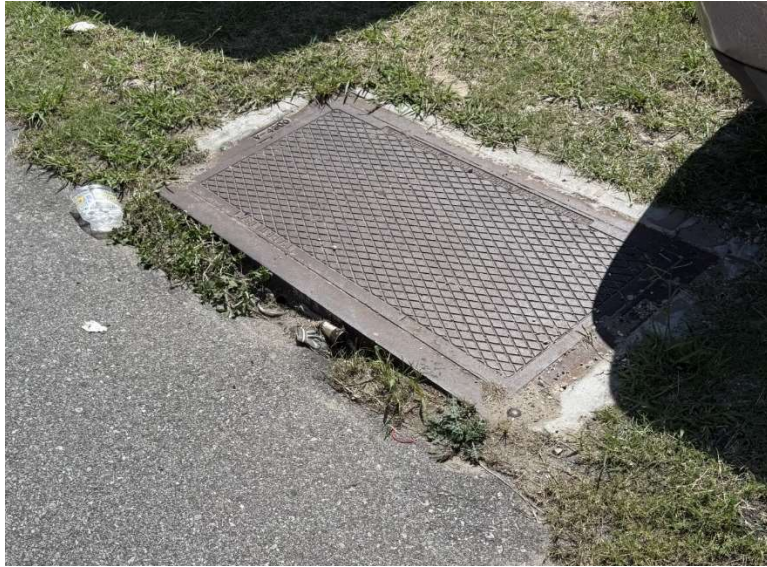
In some cases, lateral connections from the catch basins to the drain line can collapse compromising the conveyance of storm water into the system at its entry. When collapses occur at or near the catch basin, it may cause the catch basin to sink, as shown in [Figure 10](#) below, narrowing the entry of the basin and potentially severing the connection between the catch basin and the main line.

[Figure 10: Sunken Catch Basin on 900 N. Tonti St](#)

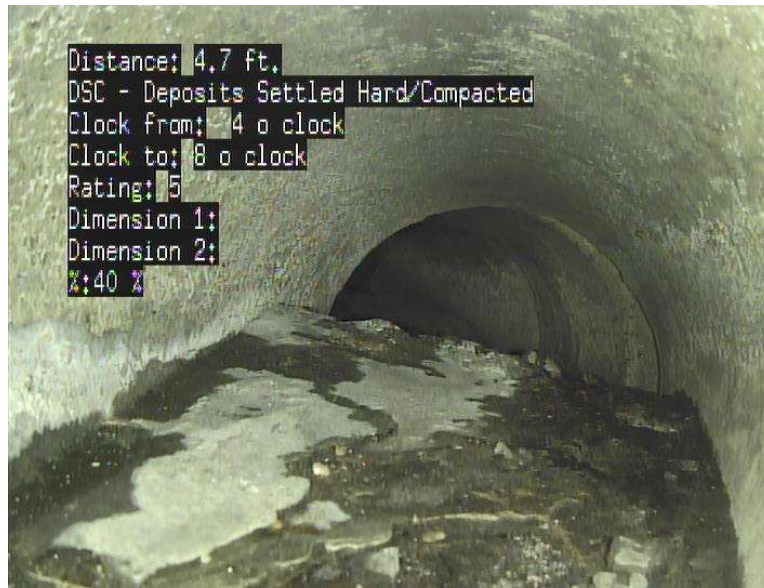
In some cases, clogs are the result of contractor malpractice, such as concrete being improperly poured or washed into a drain line during construction. As shown in [Figure 11](#), concrete inside a drainage pipe significantly reduces its flow capacity. In more severe cases, concrete can fully block a lateral or main line, particularly near catch basins, leading to immediate flooding during rainfall events. Due to the interconnected nature of the drainage network in Tremé, a clog downstream can prevent upstream water from flowing, causing water to back up and flood those upstream blocks that may otherwise function properly.

Figure 11: Hardened Concrete in Drain Pipe

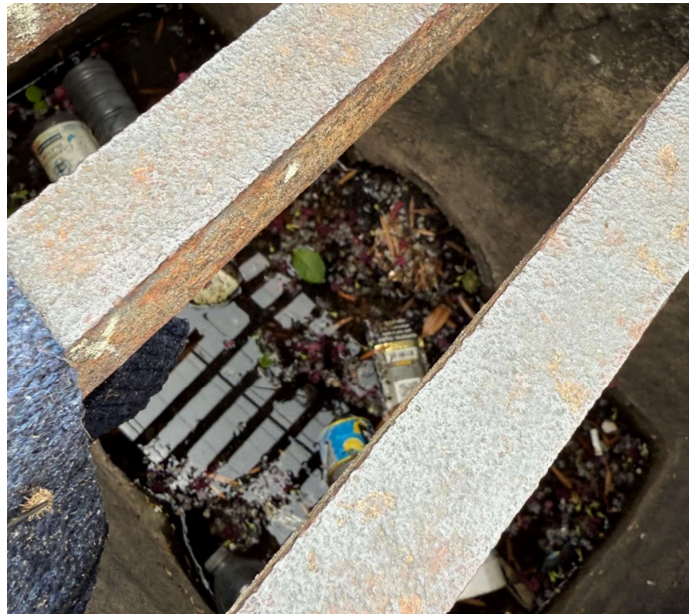
During this study, SWBNO's routine cleanings and GreenPoint's field visits revealed that streets like N. Robertson and S Johnson were almost entirely clogged with years of accumulated debris, bottles, sediment, and trash, indicating long periods without proper maintenance.

Figure 12: Visual Evidence of Blocked Inlet on 800 N. Prieur Street

These observed instances indicate that this is a pattern throughout the neighborhood with the lack of routine cleaning and maintenance, which is likely to be a large cause of the flooding in Tremé. Many catch basins remain inoperable due to this neglect, especially in heavily vegetated areas like Esplanade and St. Philip. It is unclear when many of these areas were last cleaned, and some may not have been serviced since Hurricane Katrina.

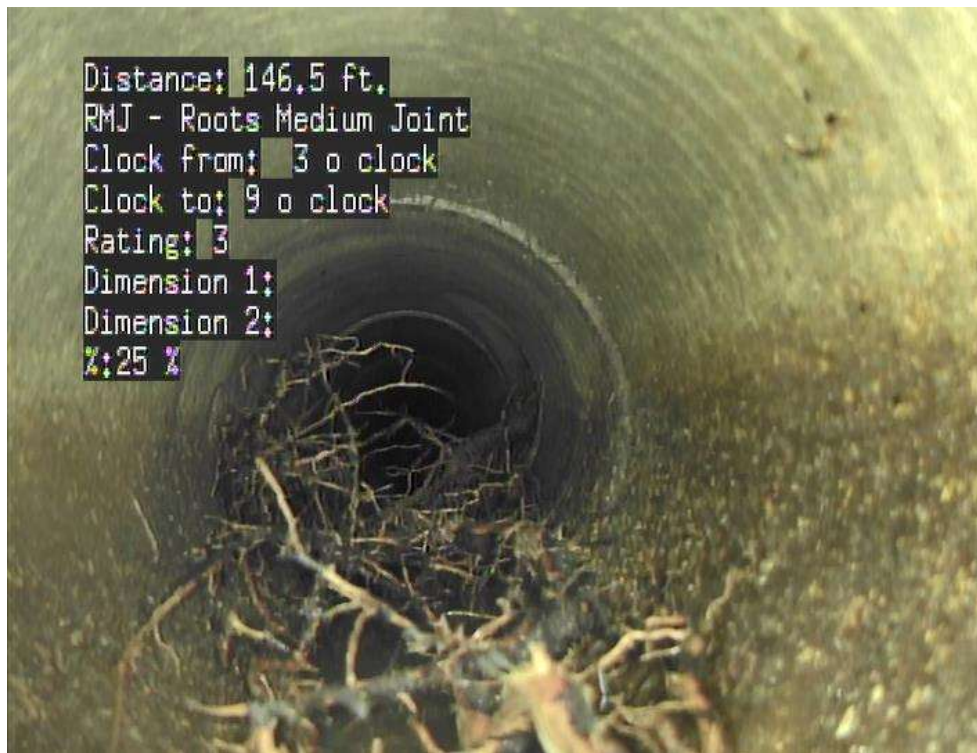
In Tremé, there are several locations where oak trees are situated directly adjacent to intersections and drainage structures such as catch basins and lateral connections. Given the age of the system, it is likely that roots have become intertwined with the drainage network. From our experience conducting CCTV inspections in similar urban neighborhoods in New Orleans, it is possible that drain lines in areas like this can be completely collapsed and blocked. CCTV will be recommended for areas of inoperable catch basins that are located in close proximity to oak trees or large trees.

Figure 13: Tree Roots Intrusion in Drain Line

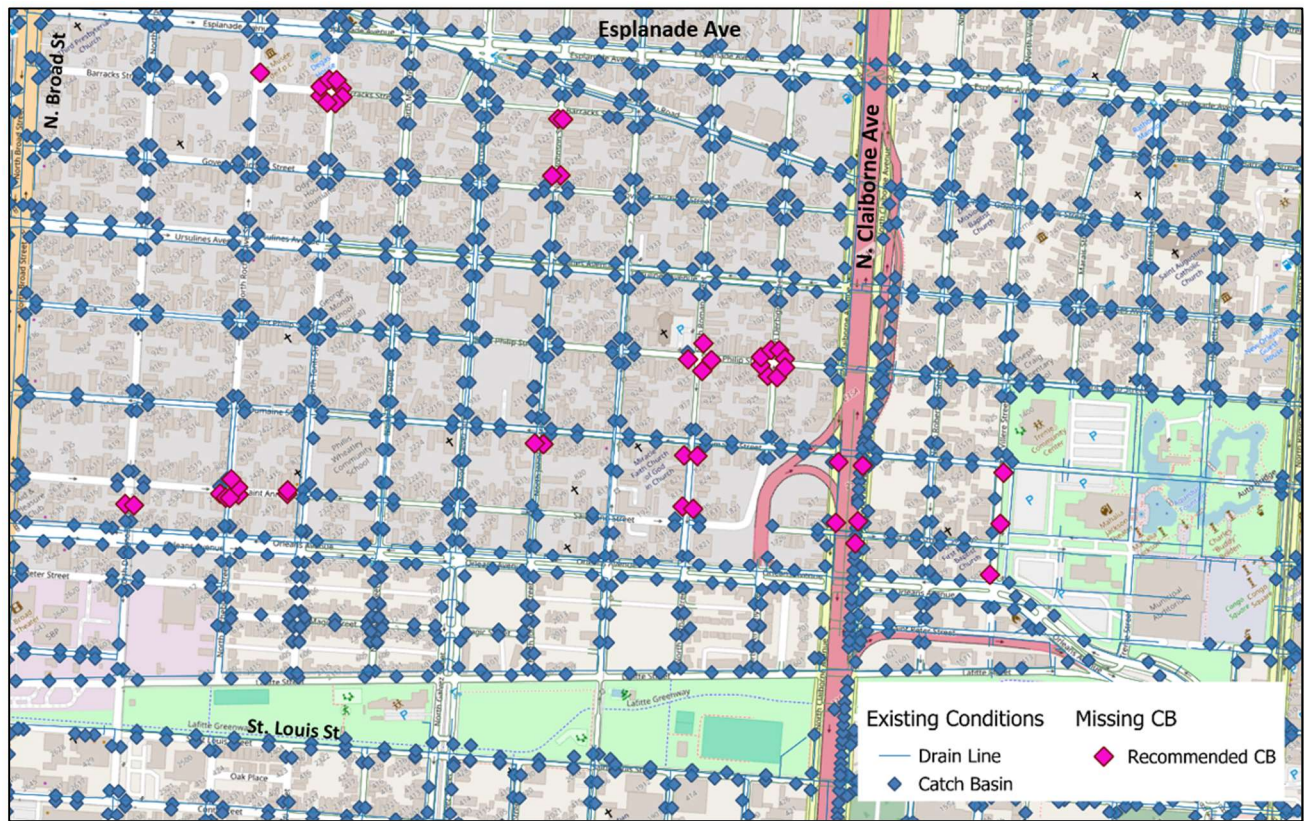
These deficiencies are mapped and documented in the GIS recommendations dataset, identifying lack of catch basins areas needing new infrastructure highlighted in pink. A complete list of these locations and proposed upgrades is included in the Project Summary spreadsheet in Appendix B.

Figure 14: GIS Map of Missing Catch Basins

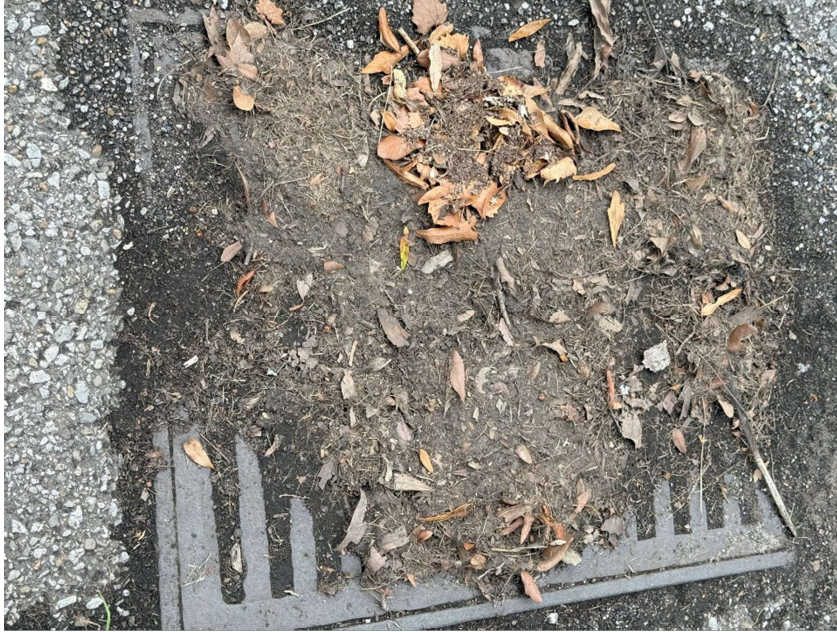
The park's elevated parking lot on the north side drains toward a limited number of four catch basins located along the internal park roads. Dense tree coverage within the park may be contributing to clogs through leaf litter, root intrusion and general organic debris.

Figure 15: Blocked Inlet in Armstrong Park

Of these limited catch basins, it was revealed during a field visit that an inlet within the parking lot near the back of the park is clogged with mud, as seen in Figure 15. Field observations confirmed additional surface runoff, likely caused by non-functioning catch basins within the park, is flowing directly into the neighborhood near N. Villere and St. Philip Streets, where flooding is frequently reported.

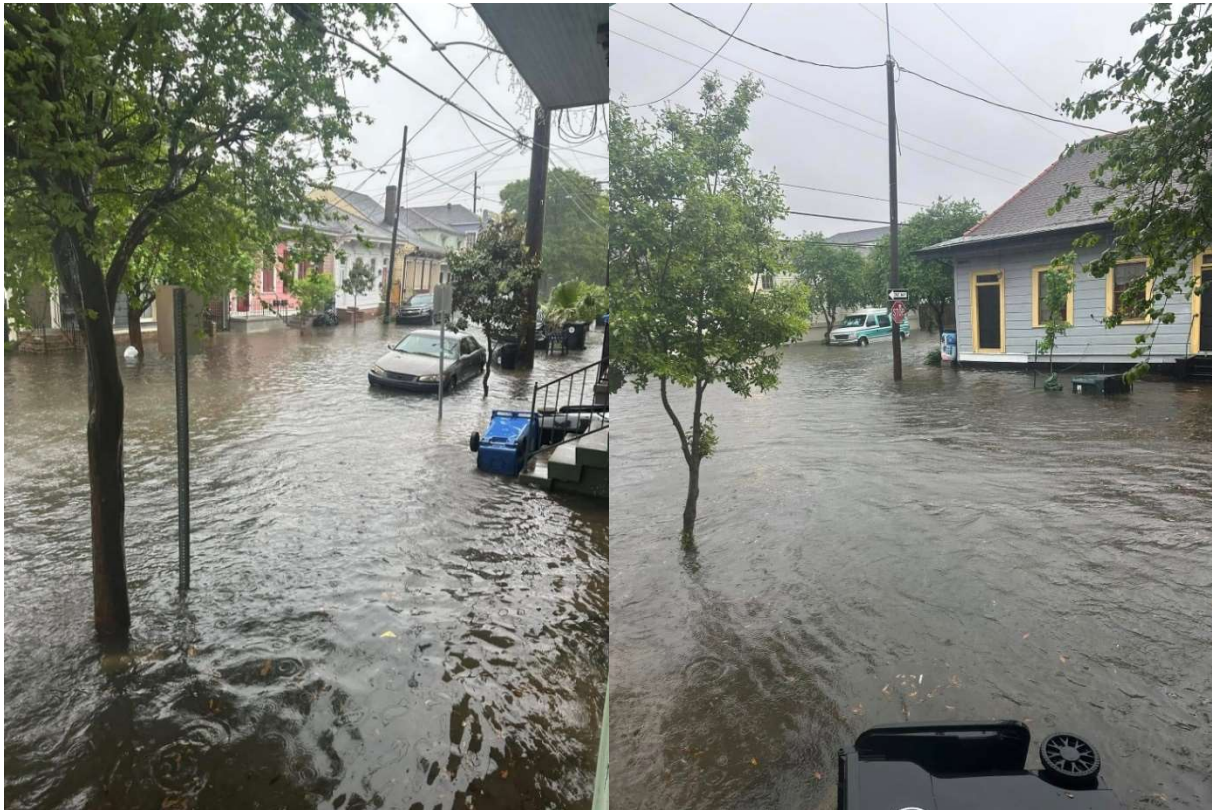
This zone, which includes the 700-900 blocks of N. Robertson and the 1500-1600 blocks of Dumaine and St. Ann Streets, has emerged as one of the most flood-prone areas in the study. Bounded by N. Claiborne Avenue and N. Villere Street, from Orleans Avenue to St. Philip Street, the area shows repeated signs of severe flooding and widespread drainage deficiencies. These findings are based on resident reports, field observations, and limited infrastructure records gathered during the investigation.

Figure 17: Flooding on 1500 Dumaine Street

As discussed in the previous section on Armstrong Park, runoff from the park appears to be a major contributor to flooding in this area. The park's elevated parking lot sheds water directly toward Dumaine and N. Villere Streets. Although catch basins exist within the park, they may be undersized and some appear to be clogged, as runoff frequently reaches the adjacent street and sits for extended periods. To add to the strain, the subsurface lines are tied directly into the drain lines on St. Ann and Dumaine- two streets that already experience frequent flooding. This dual inflow, both surface and subsurface, likely overwhelms an already stressed system.

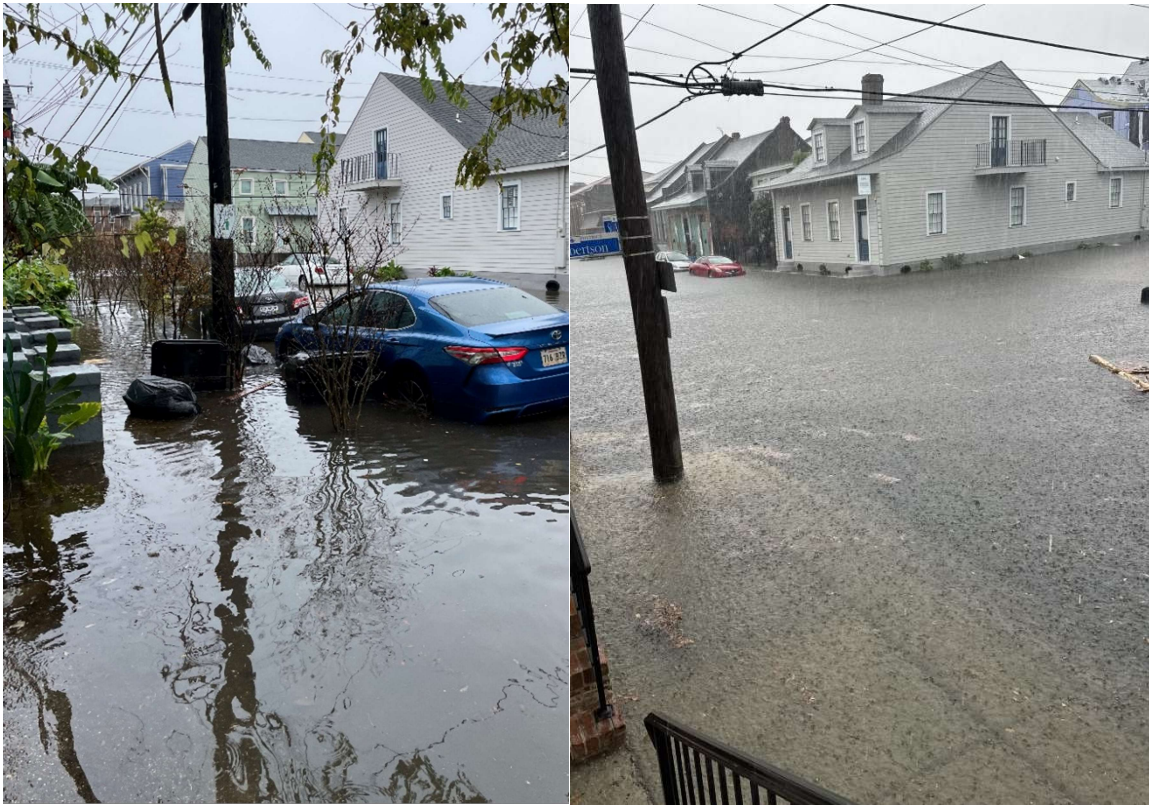
Compounding these issues is the limited drainage capacity on N. Claiborne Avenue. As mentioned in the N. Claiborne Corridor section, the corridor suffers from minimal catch basin coverage, runoff from the I-10 overpass, and frequent ponding at the on-ramps. This limits the ability of Claiborne to serve as an effective outfall for upstream areas, which may be contributing to system backups throughout the zone.

Figure 18: Flooding on 800 N. Robertson

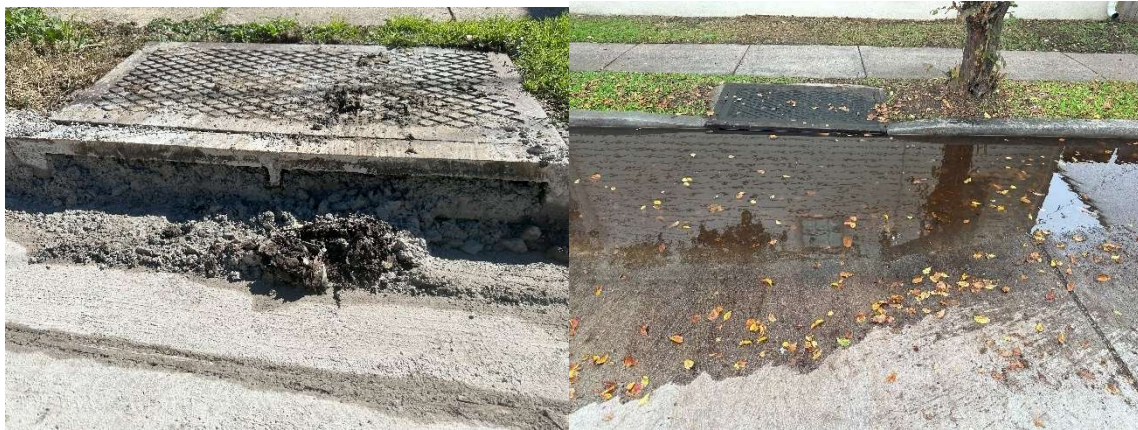
Maintenance deficiencies further complicate system performance. SWBNO field crews recently uncovered severe clogging on N. Robertson, including years of accumulated mud, trash, and debris. It is assumed that similar conditions may exist across neighboring blocks, particularly given consistent reports of non-functioning or slow-draining catch basins. Additionally, there are multiple claims of contractor malpractice. Residents have reported seeing concrete or debris poured into catch basins, particularly near St. Ann and Dumaine. While these reports have not been independently confirmed through CCTV or utility excavation, the presence of photographic evidence and consistent observations suggests that foreign material may be contributing to system blockages.

Figure 19: Resident Photos: Non-Functioning Catch Basins on 1500 Dumaine and 900 N. Robertson, respectively

Given the limited drainage infrastructure and frequency of flooding, it appears likely that several downstream lines are clogged or partially collapsed. The system layout suggests that backups on St. Philip or Dumaine may be impeding flow from N. Villere and N. Robertson, triggering a chain of localized flooding throughout the area. While these assumptions are based on available data and field observations, full system CCTV investigation will be necessary to confirm these conditions.

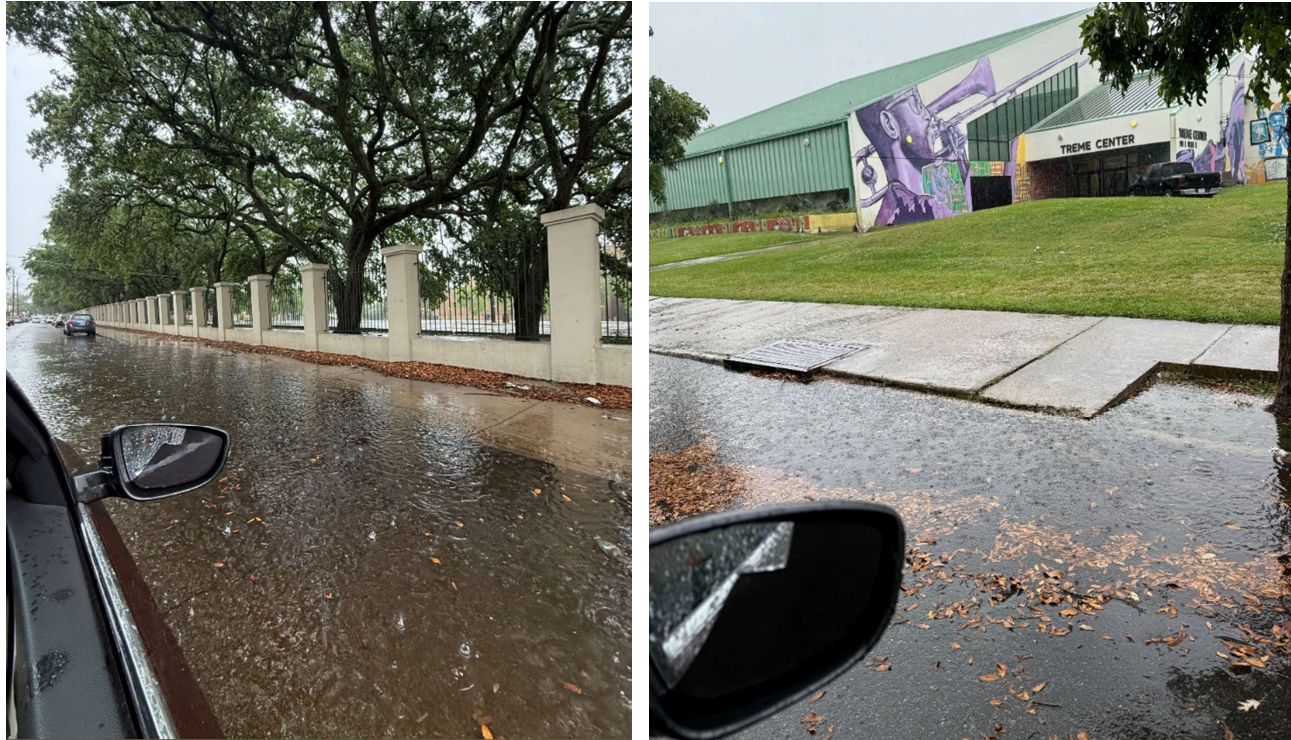
The drainage flow on St. Philip is split. Blocks from 1300 to 1600 St. Philip flow toward Claiborne, while 1100 to 1200 blocks flow toward Rampart. Several catch basins are visibly blocked, especially at intersections with N. Villere, Tremé, and Henriette Delille. In many areas, water bypasses the inlets entirely and continues onto adjacent blocks, where flooding has been observed to persist for days after rainfall. The 1200 and 1300 blocks, in particular, appear completely blocked, with stormwater bypassing the catch basins and flowing downstream.

Figure 20: Flooding on 1300 and 1400 St. Philip Street

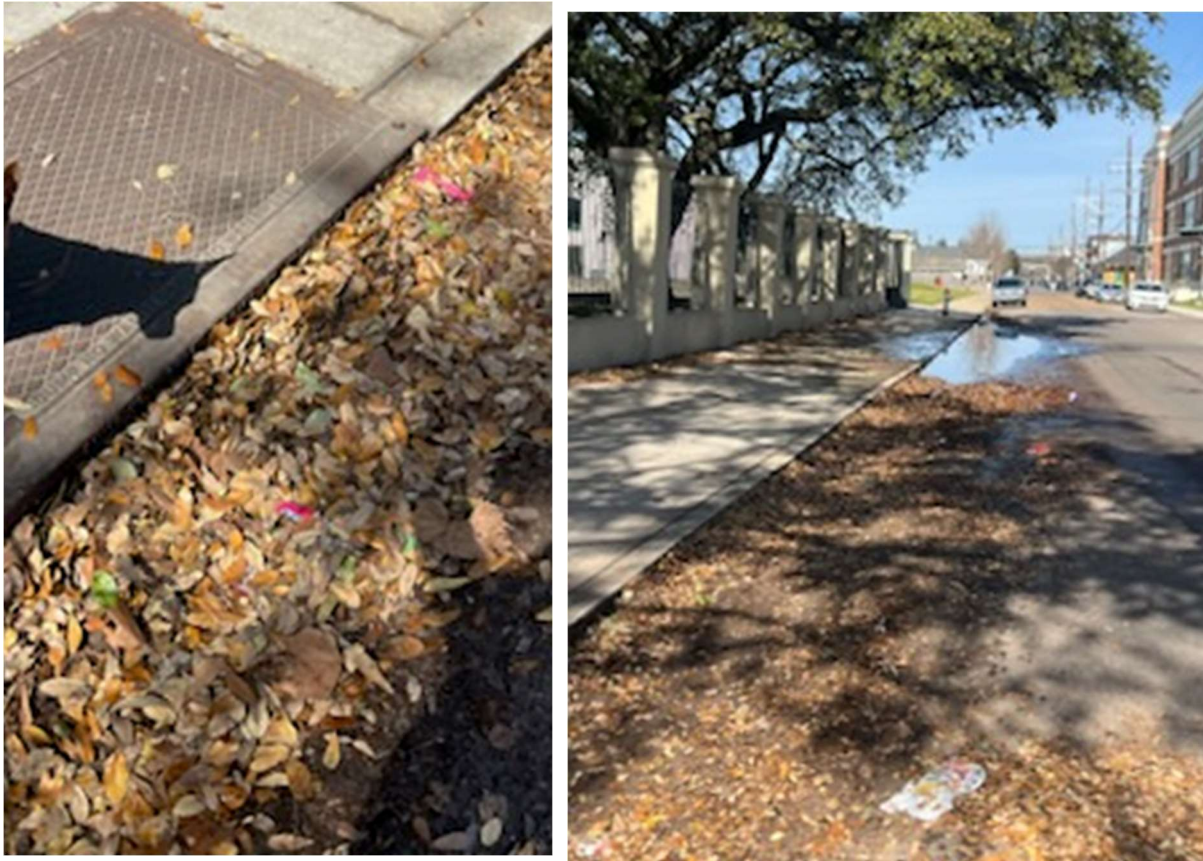
Runoff and improper leaf maintenance from Armstrong Park worsens the issue. The park's elevated lot drains directly onto St. Philip where catch basin capacity is already limited. Since drains are not operating on St. Philip, runoff from the park continues across and into adjacent streets like Tremé. Debris trails and standing water indicate system-wide clogging. This runoff, combined with regular leaf fall from the adjacent trees, creates a feedback loop of clogging and overflow that impacts multiple blocks downstream.

Figure 21: Evidence of Leaf Accumulation on 1300 St. Philip Street

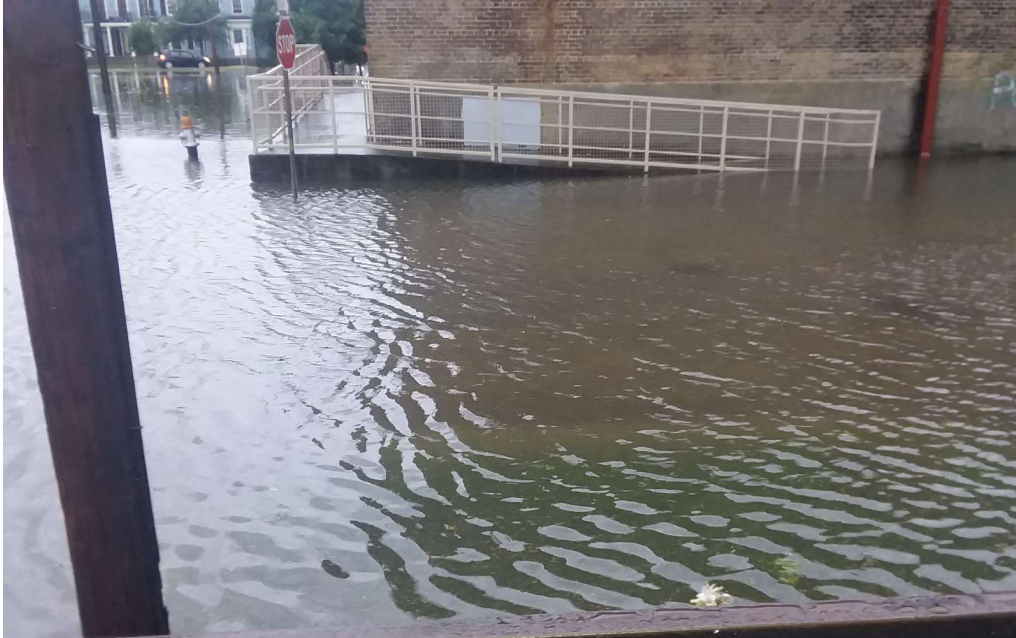
This area has been identified as one of the two highest priority zones in the neighborhood. This zone covers the 800 to 1000 blocks of N. Johnson Street, stretching from Orleans Avenue to Ursulines, and includes adjacent and intersecting blocks such as N. Galvez, N. Prieur, St. Ann, Dumaine, and St. Philip. It has widespread reports of flooding, severe clogging, and overall drainage system failures. Residents report water taking several hours to drain even after moderate rain. In one case, a resident measured 10 inches of standing water during a February 2024 storm.

Figure 24: Flooding on St. Ann and N. Johnson behind Carver Theater

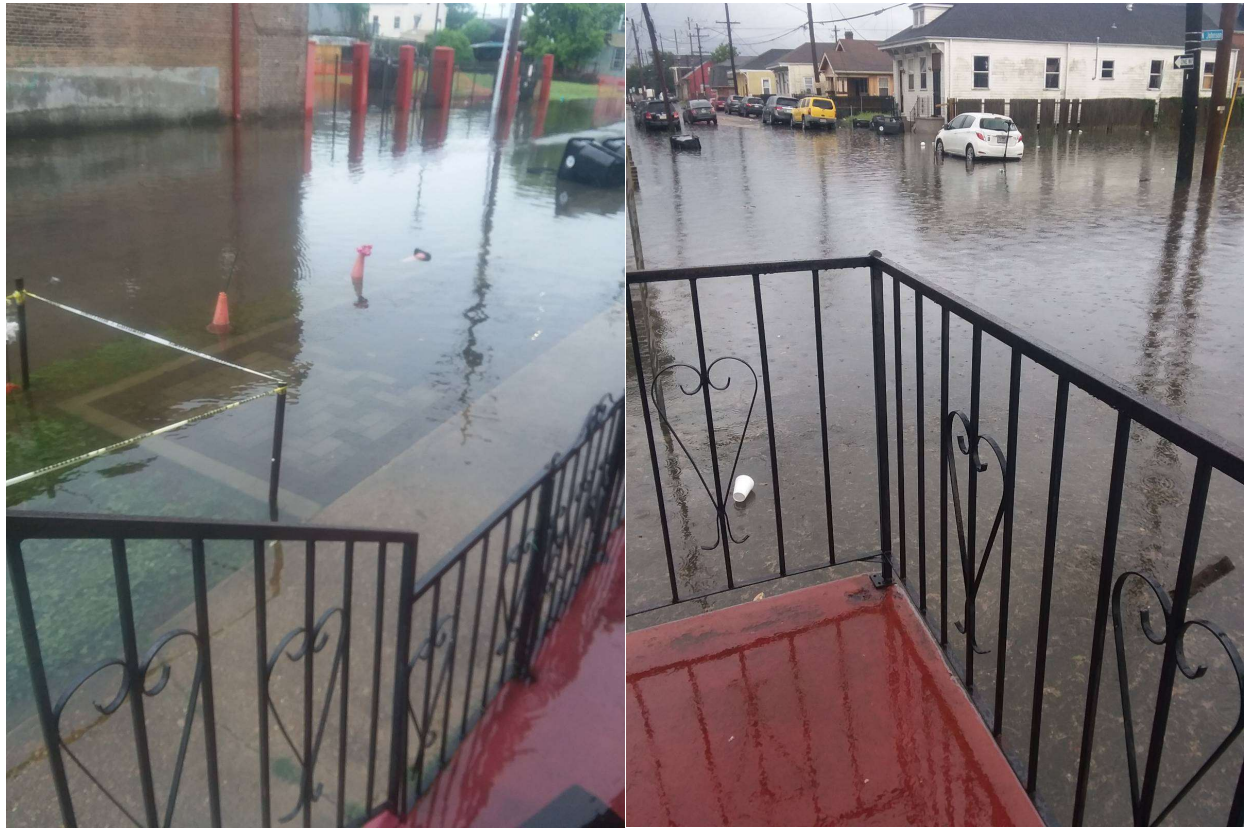
Figure 25: 2000-2100 St. Ann and N. Johnson

Field observations and resident photos show standing water, debris, and non-functional inlets across nearly every block. There is also evidence of structural deficiencies, like sunken concrete or sidewalk cave-ins, which may indicate broken laterals or collapsed lines. The intersection of St. Ann Street and N. Johnson has been a large concern of residents. The 2000-2100 blocks of St. Ann don't have curbs and don't appear to be graded in a way that allows proper flow of water to the catch basins. This intersection didn't originally have drainage provisions. In recent years, however, two new inlets have been installed on the 800 block of N. Johnson near the intersection, and one new inlet in the intersection roadway itself.

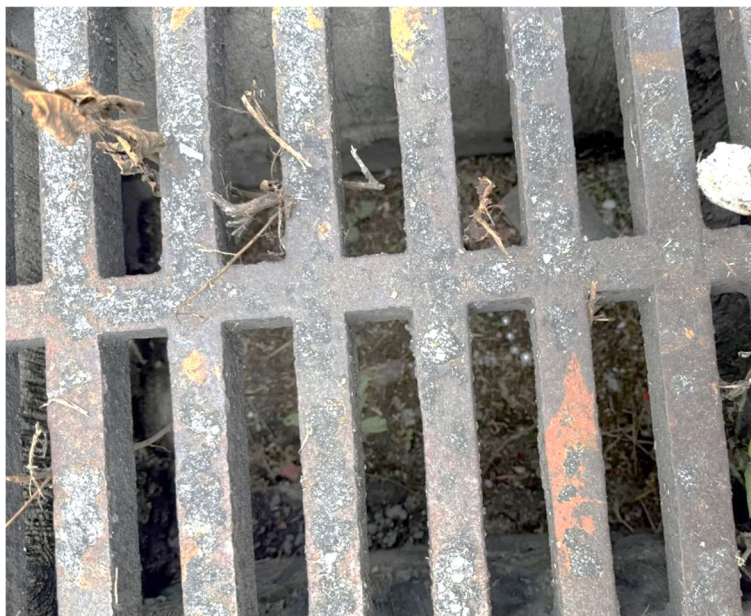
During a field observation, it was observed that the inlet at the intersection of N. Johnson and St. Ann is completely filled with compacted mud, blocking the connection to the pipe and preventing any flow. This inlet is at the 700 block at the downstream end of the system, validating the assumption that backups at this point are responsible for failures upstream. When these outfall lines are blocked, as appears to be the case here, it creates a chain reaction of flooding throughout the entire zone. Until this blockage is addressed, no upstream system improvements will be effective.

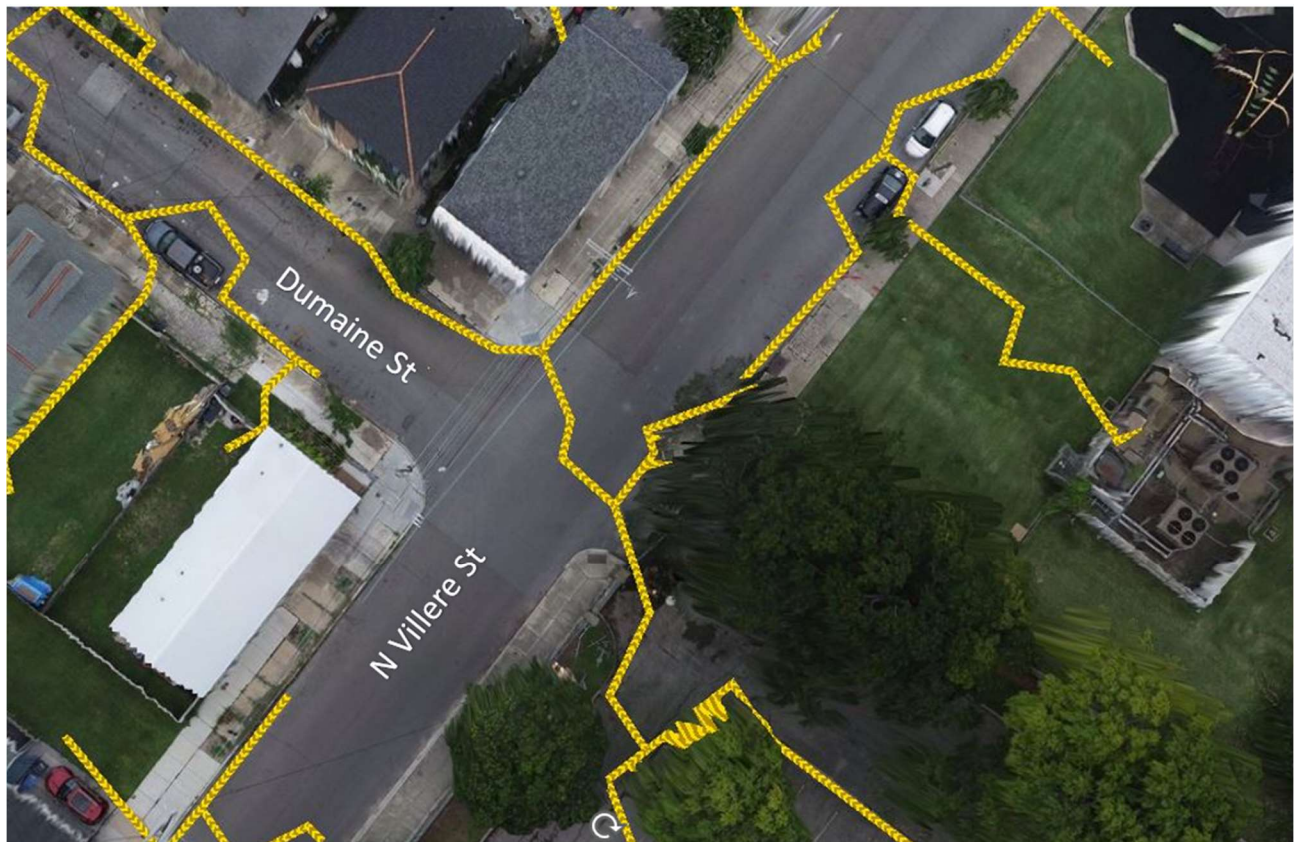
A closer look in [Figure 37](#) focuses on the corner of N. Villere Street and Dumaine Street. The flow analysis shows runoff streams bypassing catch basins on N. Villere and continuing down Dumaine, indicating N. Villere may not be graded properly, resulting in the catch basin near the corner of Dumaine to act as an intermediate catch basin rather than a low-point catch basin. An intermediate catch basin will only collect a fraction of the runoff while the rest flows to the next low point. Therefore, the inlet may not be effectively capturing stormwater runoff from the parking lots of Armstrong Park and Tremé Community Center. As a result, larger volumes of runoff are entering the residential portion of the neighborhood. By combining this flow data with field observations, we can assess the catch basins around the neighborhood and evaluate which catch basins are optimally placed to collect runoff and which may be poorly positioned or obstructed.

Figure 37: Figure 33: Flow Analysis of N. Villere and Dumaine Intersection

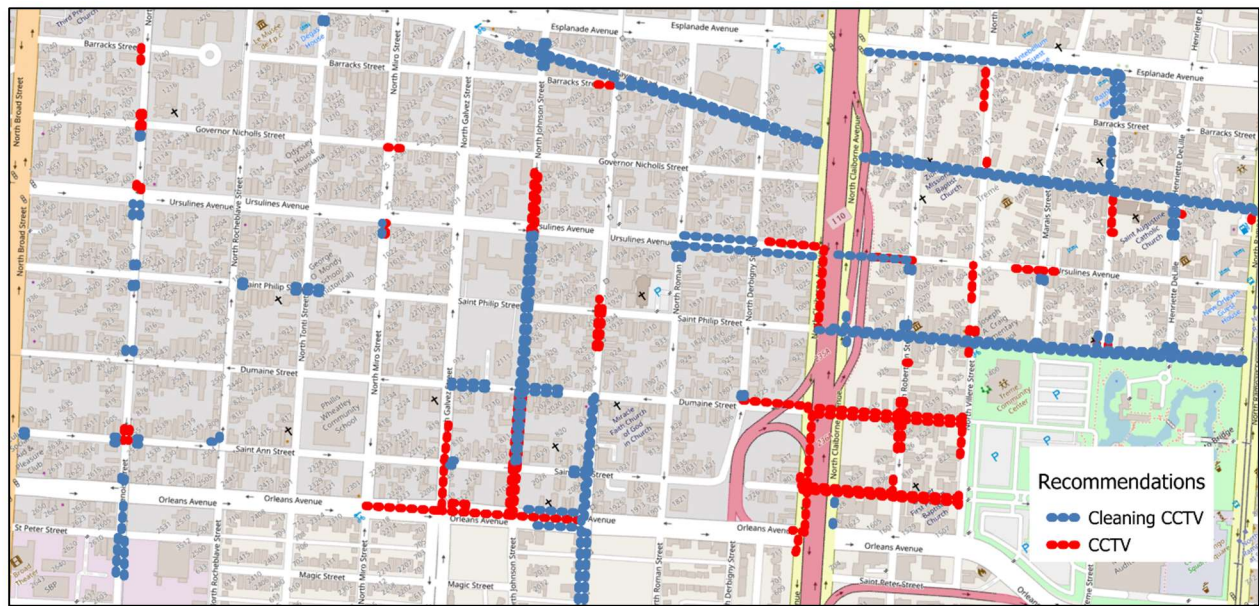
Figure 38: GIS Map with CCTV and Cleaning Recommendations
