# Technical Memorandum

## The Seventh Ward Urban Flooding Investigation

Technical Memorandum

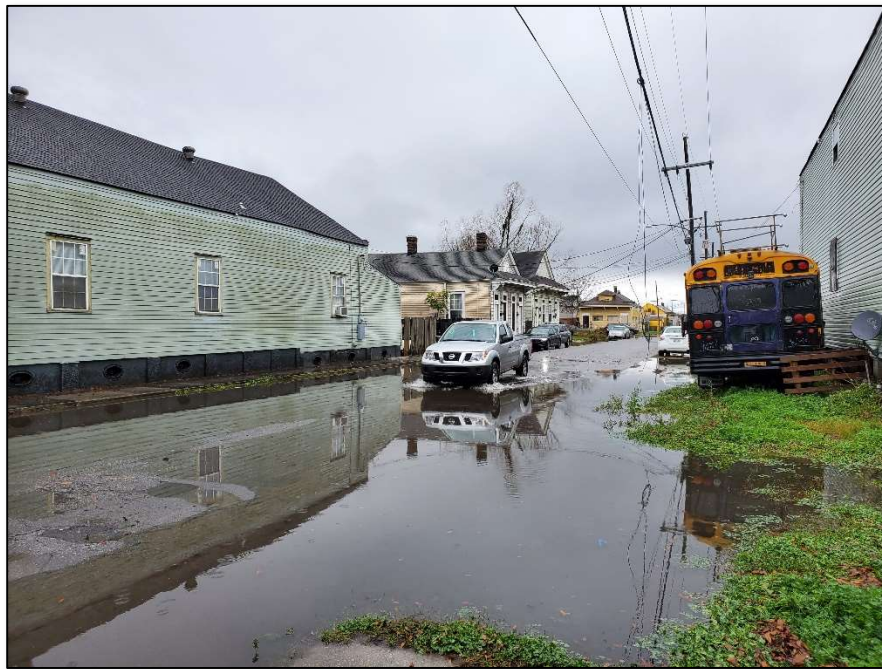
Figure 4: Resident Photo of Flooding on 2100 N. Prieur Street

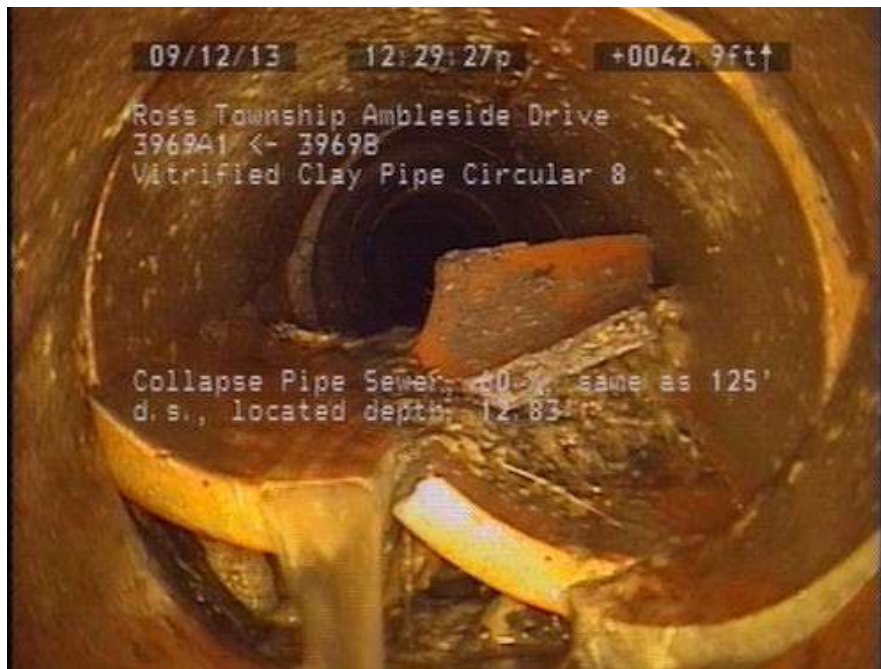
Over time, the structural integrity of these pipes degrades, particularly in a city like New Orleans where the ground is constantly shifting due to subsidence. These ground movements can lead to joint displacements, cracks, and even full pipe collapses. Additional utility conflicts and failures can occur with the drain system sharing the same roadway with other utilities like gas, water and sewer. **Figure 10** below is an example from a previous drainage project performed by GreenPoint of a gas line bored through a pipe where a water leak is entering the drainage system. These types of failures not only reduce the capacity of the drainage network but can also create conditions for sinkholes, surface flooding, and ongoing infrastructure deterioration.

Figure 9: Example of Broken Terracotta Drain Line

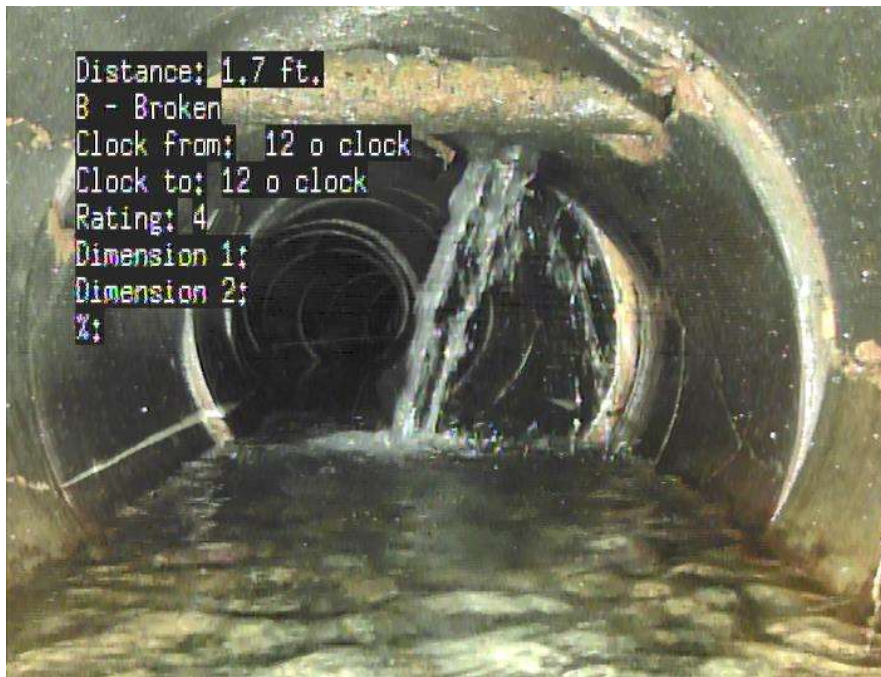
Figure 10: Example of Water Leak Intrusion to Drainage Pipe

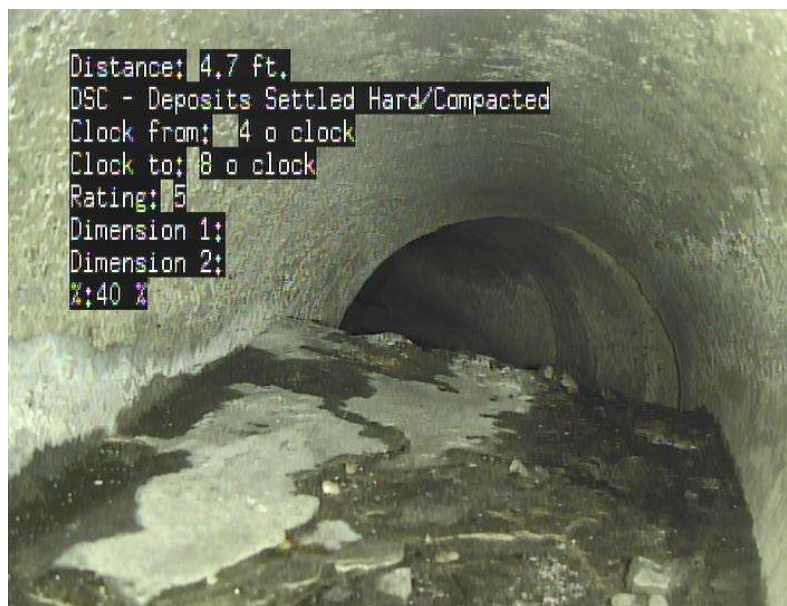
Figure 5: Hardened Concrete in Drain Pipe

This results in surface ponding and street flooding, even during minor rain events. Because the drainage network in the Seventh Ward is highly interconnected, a clog downstream can prevent upstream water from flowing, causing water to back up and flood those upstream blocks that may otherwise function properly.

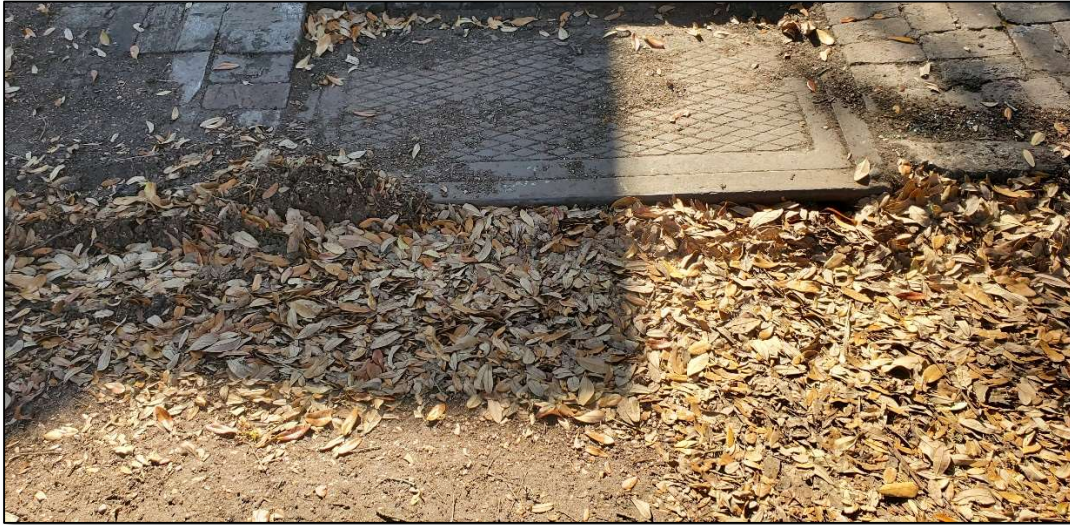
Field observations and resident reports confirm widespread litter and long-term trash accumulation throughout the neighborhood. The pattern of clogged basins and neglected lines is consistent across the neighborhood, pointing to a lack of routine cleaning and maintenance. In Tremé, SWBNO's cleanings and GreenPoint's investigation revealed that some streets in the neighborhood were almost entirely clogged with years of accumulated debris, bottles, sediment, and trash. Evidence suggests that the Seventh Ward has experienced similar long gaps in maintenance, with some areas likely not cleaned since Hurricane Katrina. As a result, many catch basins remain ineffective, particularly in heavily vegetated corridors such as Esplanade and N. Broad, where leaf litter compounds the problem.

Figure 12: Blocked Catch Basin on 1800 Elysian Fields Ave

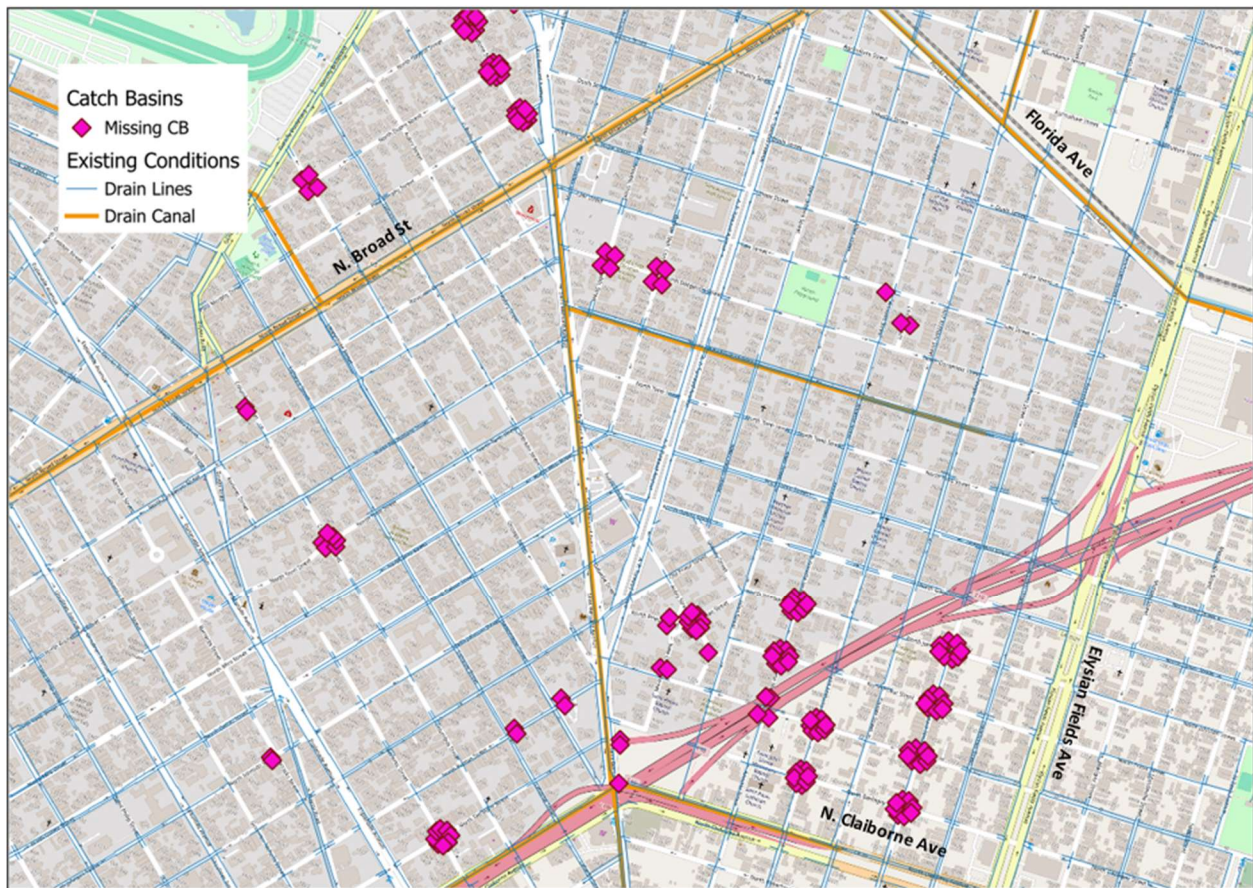
These gaps are mapped and documented in the GIS recommendations dataset, which identifies locations requiring new catch basins (highlighted in pink). A complete list of these areas and proposed infrastructure upgrades is provided in the Project Summary spreadsheet in Appendix B.

Figure 14: GIS Map of Missing Catch Basins

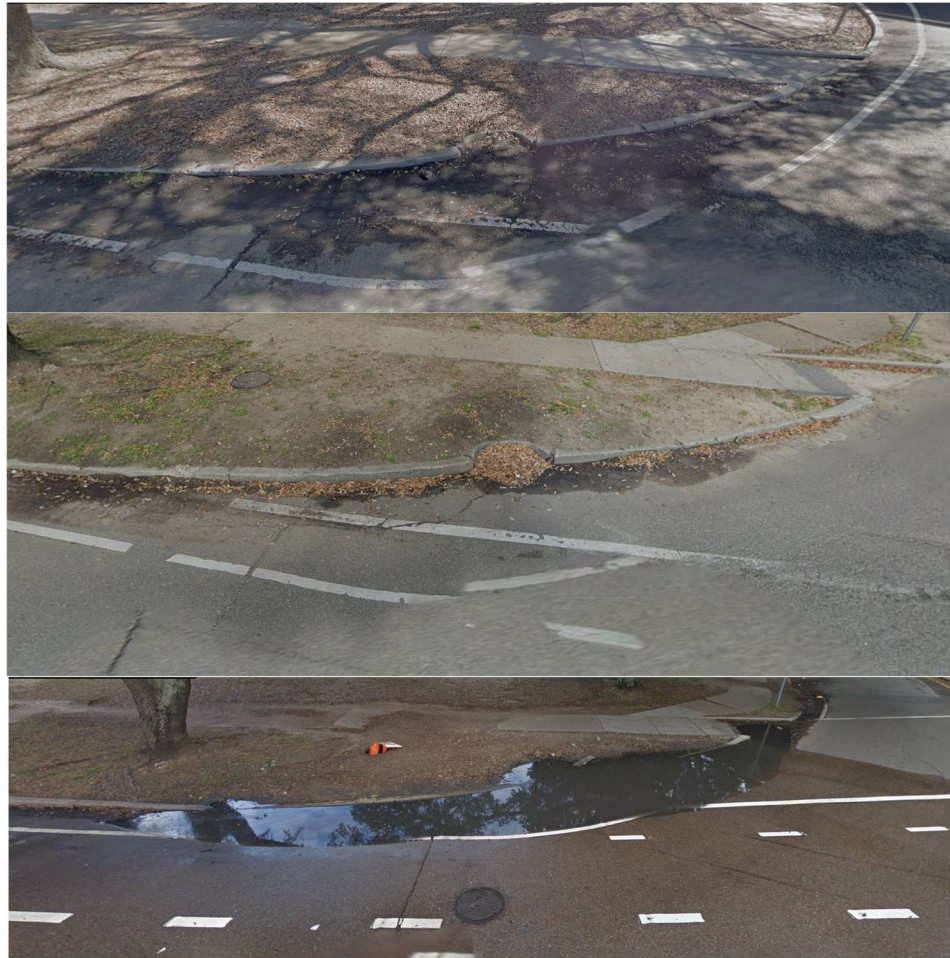
At St. Bernard and Claiborne, residents report the intersection from the I-10 off-ramp becomes impassable, with Hunter's Field quickly flooding along its rear walkways even in moderate rainfall. St. Bernard Avenue is heavily lined with oak trees and the inlet openings near the park are undersized and clogged with mud and leaves. Flooding here is exacerbated by runoff from the interstate ramps that overwhelms the poorly functioning drainage at this location. **Figure 16** below is from Google Earth and shows a clogged inlet at this off-ramp on St. Bernard, with persistent blockage dating back to 2011.

Figure 8: Google Earth 2011 to 2025 Imagery of Clogged Inlet at St. Bernard and N. Claiborne

Low spots on the block are designed to collect water to drain but this low spot now functions as a permanent basin, holding excess runoff with no working outlet. It is likely the other catch basins and drain lines along St. Bernard are in similar condition creating a backup along the avenue and upstream blocks like N. Claiborne and the back of Hunter's Field. At the rear of Hunter's Field, around the 1600-1700 blocks of Allen Street, the residents have documented knee-deep flooding during minor storms, with repeated 311 reports and prior repair attempts that failed to improve conditions. Though it can be deduced that I-10 is a driving factor in flooding at this location, CCTV and cleaning of the drain lines will be necessary to truly determine the root cause. Considering green infrastructure in the short term at Hunter's Field is recommended and discussed in the following sections.

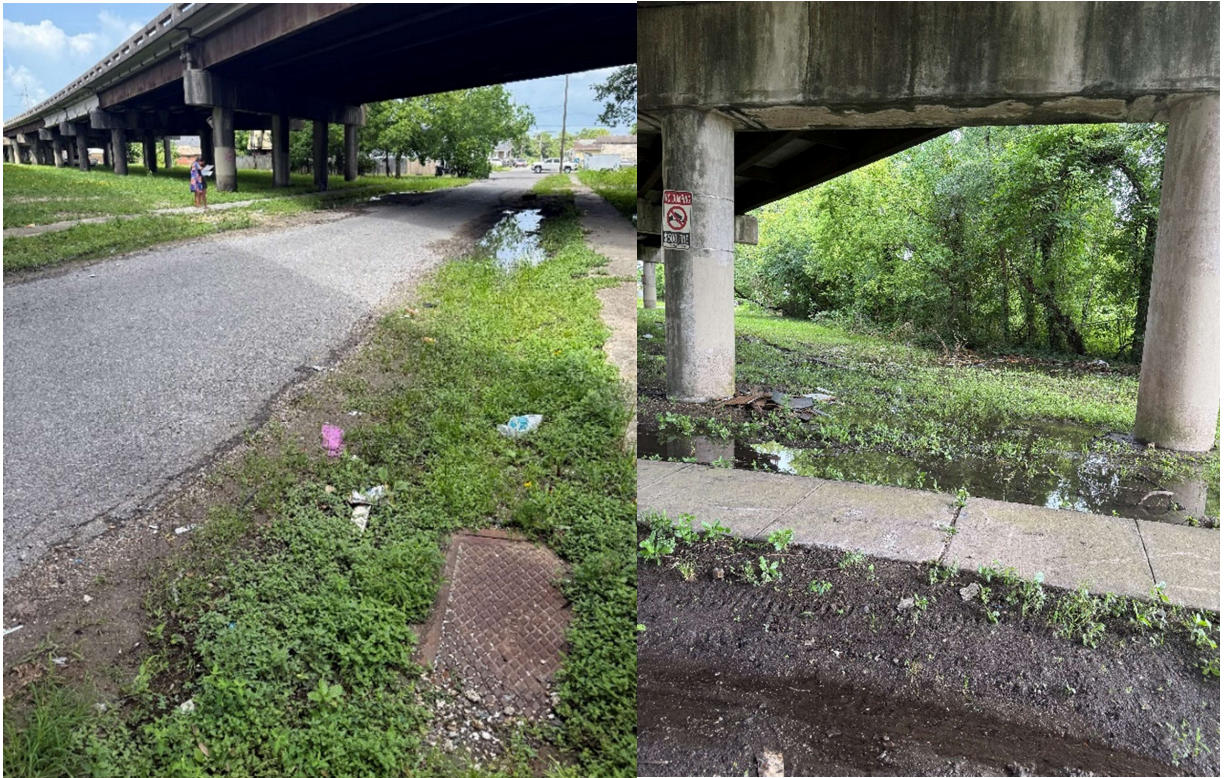
excess interstate runoff. The flooding is compounded at intersections such as Annette and Roman, St. Anthony and Prieur, and N. Johnson and Pauger, where runoff collects at low points where the limited drainage at these locations have reports of being inefficient and clogged with debris, further reducing the already limited capacity.

Figure 9: Flooding and Clogged CB Under I-10 at N. Johnson St

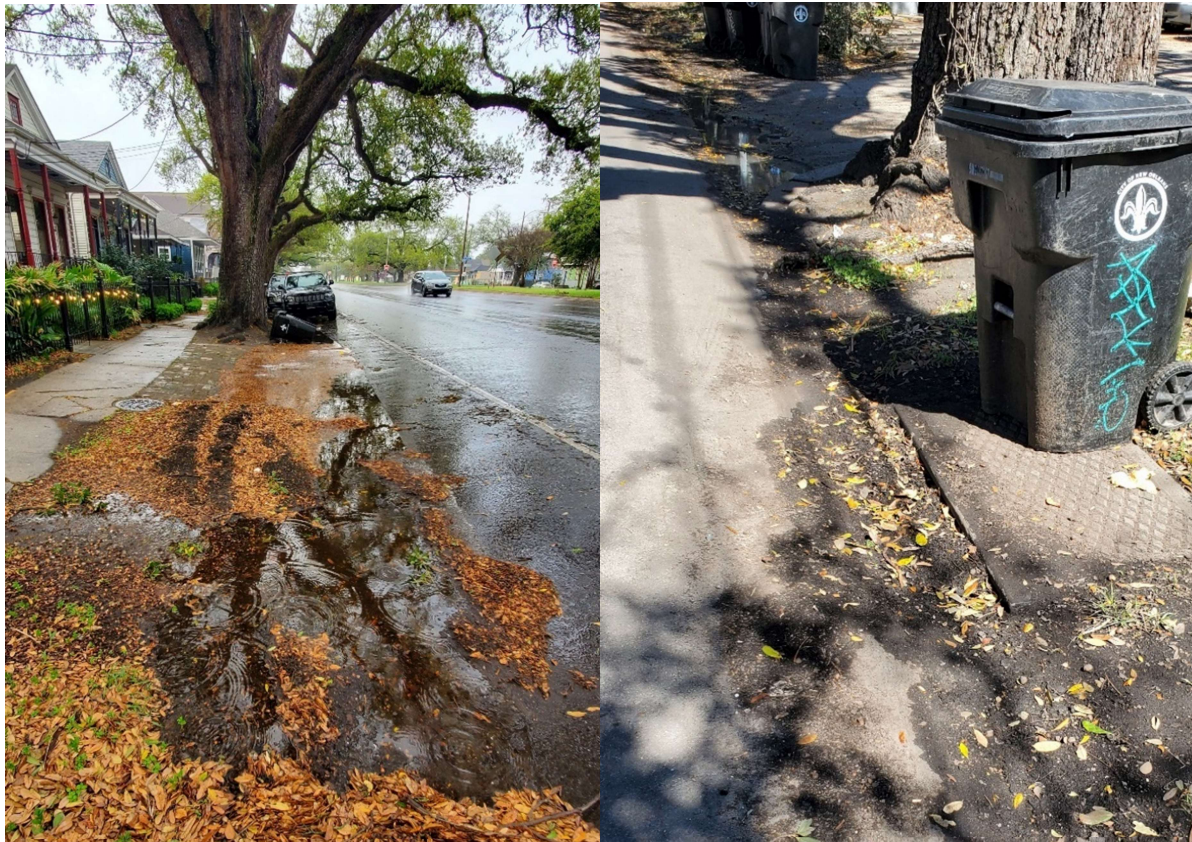
Blocks 1600-2100 are heavily lined with mature oak trees, contributing to recurring clogging of inlets and potential compromise of buried lines due to root intrusion. Landscapers have been reported to be blowing leaves into the street exacerbating the problem, clogging inlets and filling parking lanes with debris. Reports confirm clogged catch basins and sediment or leaves buildup across the length of the block.

Figure 21: Evidence of Leaves and Clogged Catch Basin on 1900 Elysian Fields

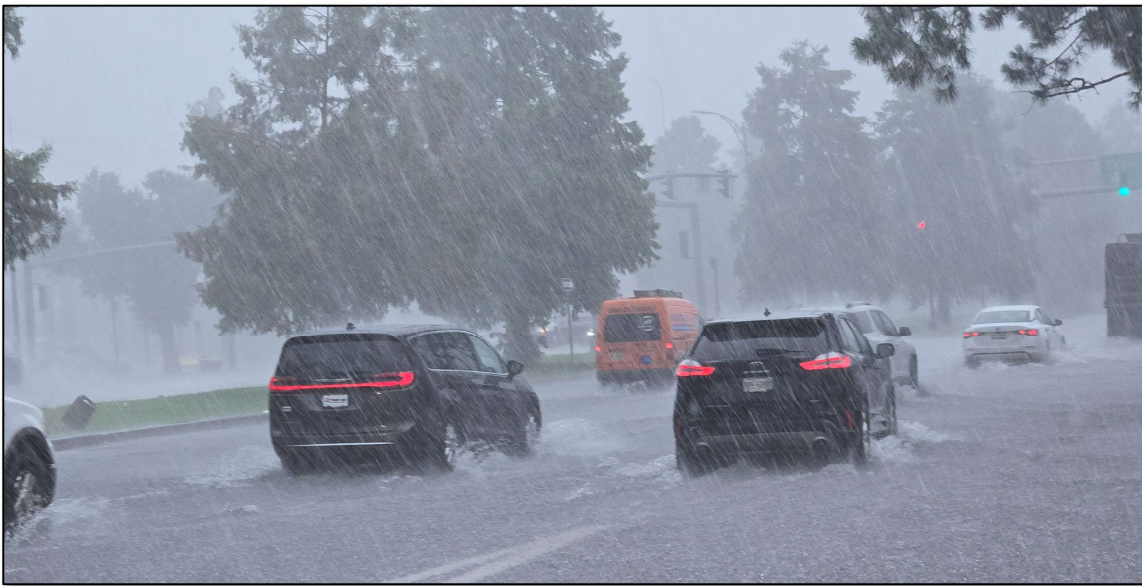
Conditions worsen on blocks 2100-2700 toward Florida Avenue, particularly under the I-10. Water from the interstate overpass sheets directly onto Elysian Fields near the Lowe's at Florida Avenue, with runoff collecting in low spots and remaining long after rain events. Residents reported that as little as two inches of rainfall rendered both northbound and southbound lanes impassable, with vehicle wakes forming along the roadway. Multiple listening session participants confirmed that portions of the corridor never dry, with standing water, debris, and clogged catch basins noted even during dry weather.

Figure 22: Flooding at N. Dorgenois and Elysian Fields

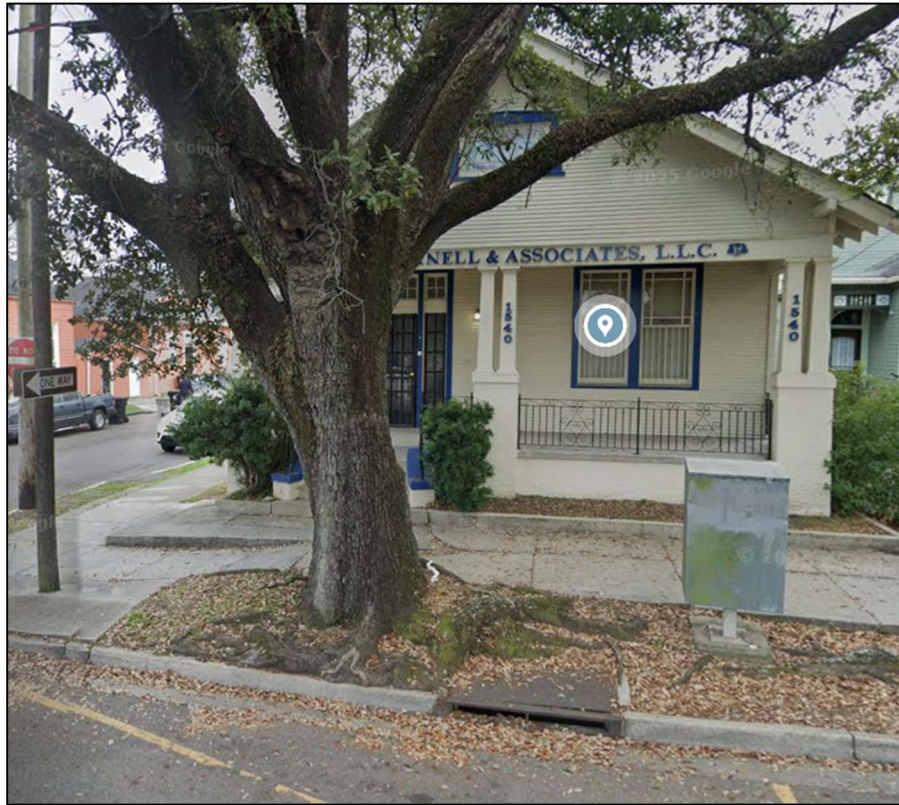
The entire corridor of N. Broad is lined with large oak trees, in many instances which have matured directly adjacent to catch basins. The root systems of these trees are likely breaking or dislodging drain lines, causing blockages and preventing water from flowing properly. In the photo below you can see the roots behind and along the sides of the catch basin. The root system below this tree is probably extremely dense, collapsing the drain line. Of course, CCTV would need to be performed on this lateral and the drain line to confirm this assumption.

Figure 24: Catch Basin and Oak Tree Proximity at 1540 N. Broad St.

Almost every block along this corridor has a mature oak tree growing next to a catch basin like in **Figure 24**. Resident and field reports confirm this pattern across multiple addresses reporting catch basins clogged with debris, displaced or collapsed due to tree root intrusion, and standing water remaining long after rainfall. In some cases, basins appear completely inoperable or missing, while in others, damaged inlets have created sidewalk hazards. Together, these conditions indicate that tree-related damage, basin clogging, and broken connections are widespread along N. Broad and is the more likely suspect of the flooding along this corridor.
