# Technical Memorandum

## Tremé Urban Flooding Investigation

Technical Memorandum

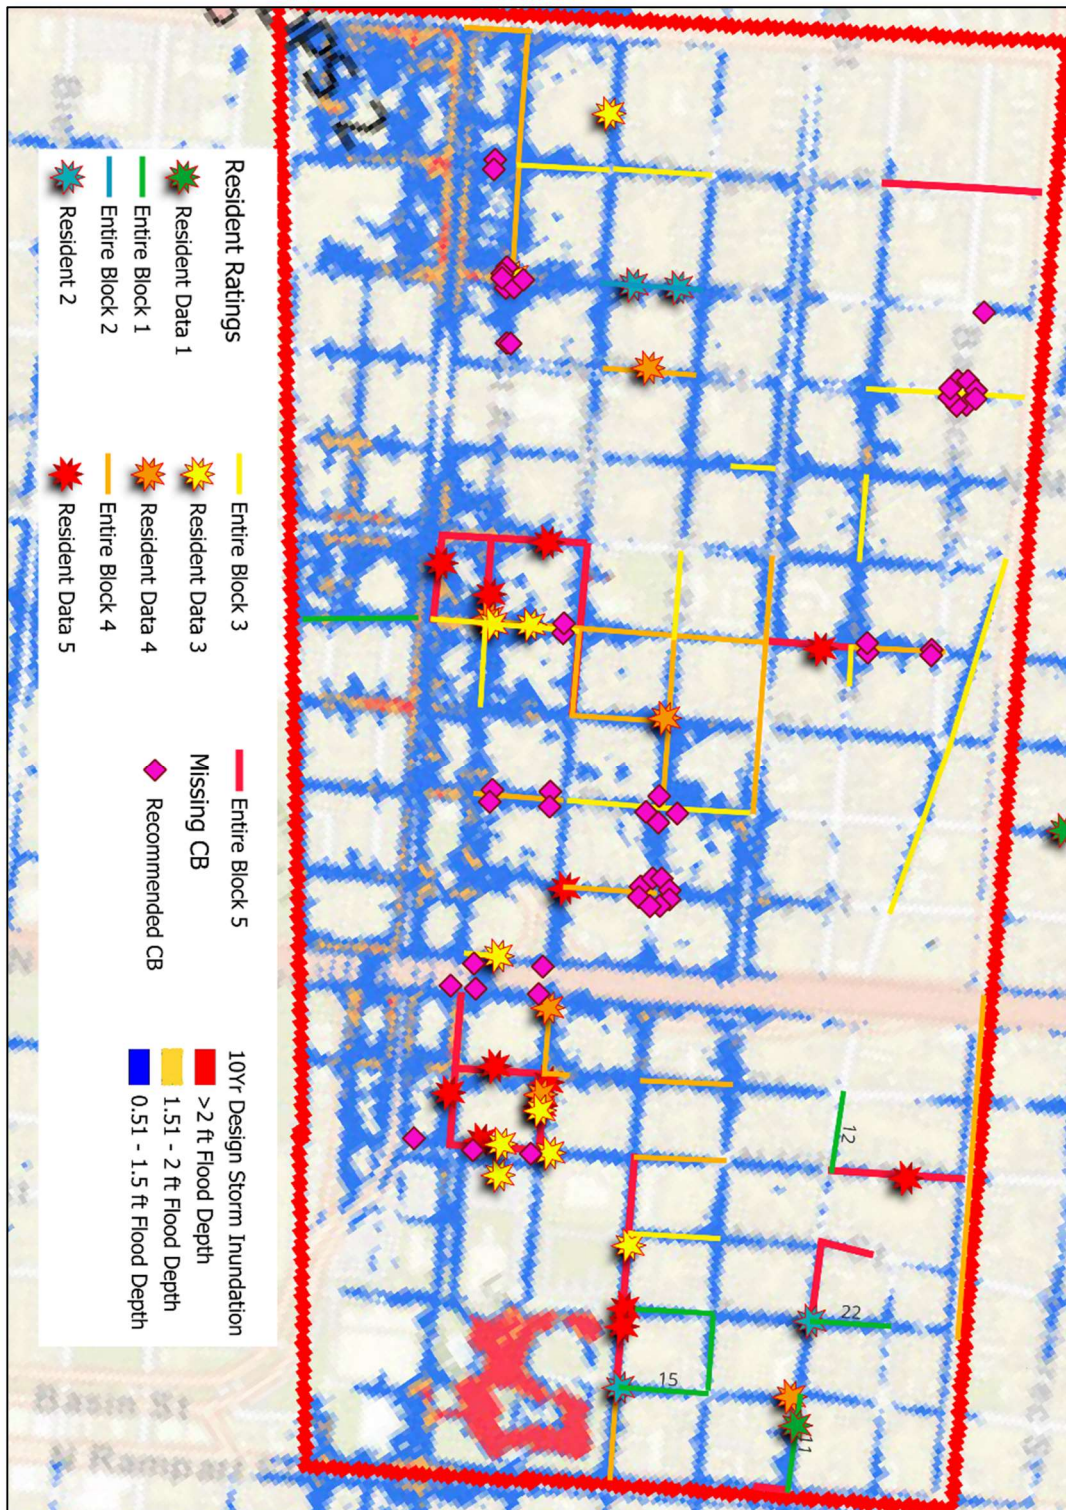
Figure 31: 10-Yr Inundation Map with Resident Ratings

**Figure 31** below, shows how areas without catch basins contribute to the inundation levels in the area. It should be noted that the large area of deep flooding around Armstrong Park area is indicative of the lagoons.

Overall, the model outputs support the conclusions and reinforce the need for immediate cleaning, CCTV inspection, and potential upsizing in key areas. Select inundation maps and relevant excerpts from both reports are included in **Appendix C** for reference.

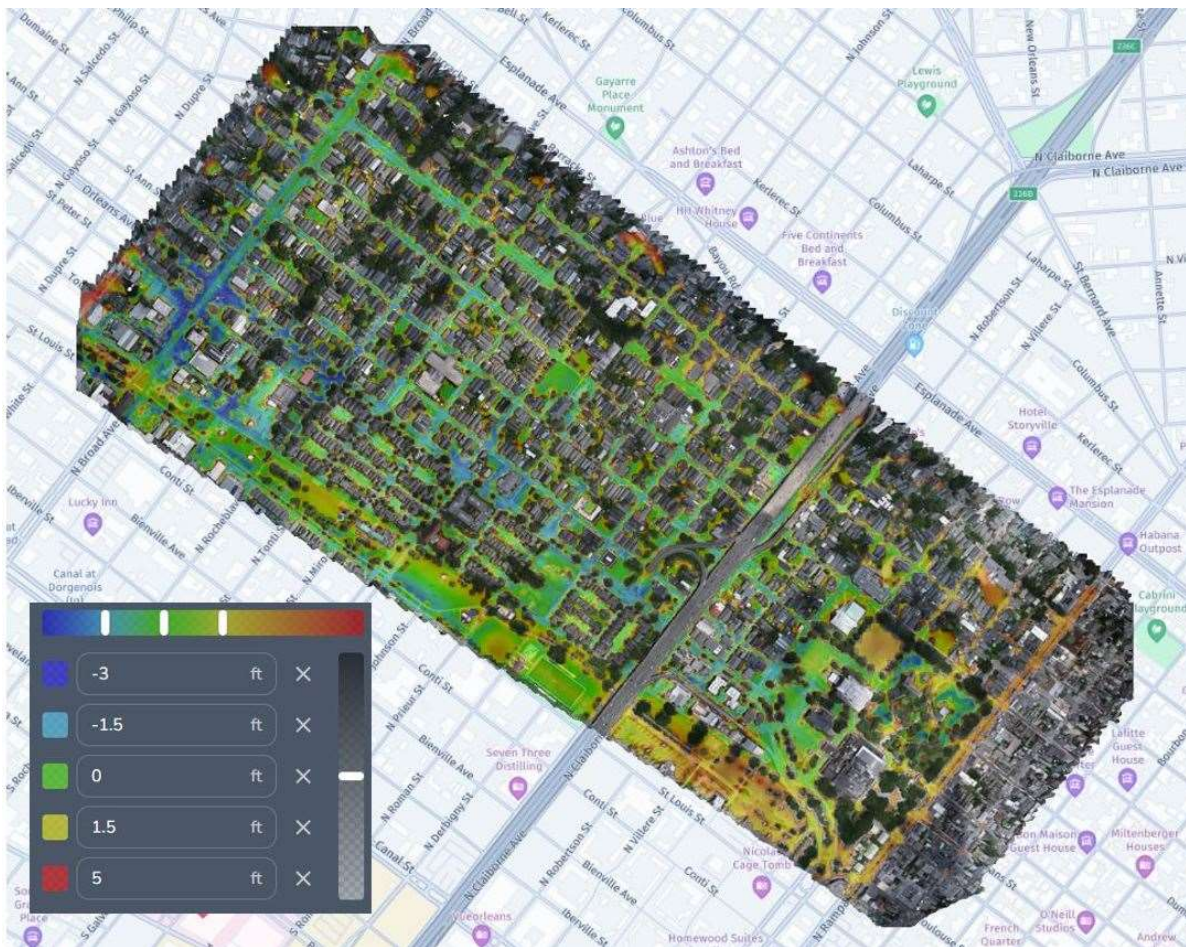
Figure 32: Topographic Elevation Heat Map of Tremé Neighborhood

Figure 32 below is a topographic heat map of the entire investigation area, showing street elevations relative to the rest of the neighborhood. This map highlights critical depressions and low points in the roadway network, many of which align closely with resident reports of frequent flooding. Dark and light blue areas indicate surface elevations between 0 and –3 feet, representing low points. Yellow and red areas show higher elevations between 0 and 5 feet.

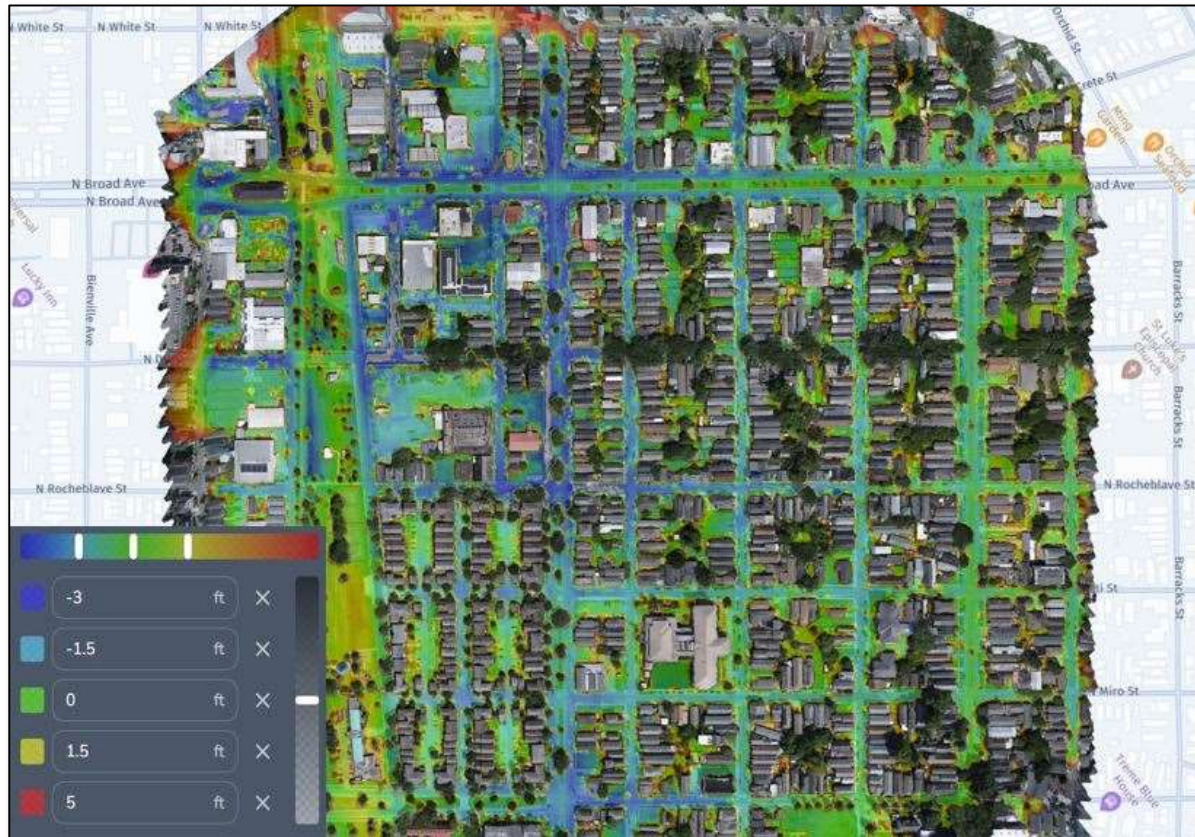
Figure 33: Topographic Elevation Heat Map – North Broad to Galvez St.

Figures 33–35 provide closer views of different sections of the neighborhood for a more detailed interpretation. Consistent with field observations, low points were identified along N Broad Street and throughout Orleans Avenue, which is a primary outfall connected to the Orleans Avenue Canal. These

correlations support resident reports of standing water at these locations. The elevation data also confirms that St. Louis Street and N. Rampart Street are higher in elevation, explaining some differences in flooding behavior around these corridors. The low spots on this map are good indications of areas that should be prioritized for cleaning and maintenance to ensure they can effectively receive flow from adjacent blocks that are higher in elevation.

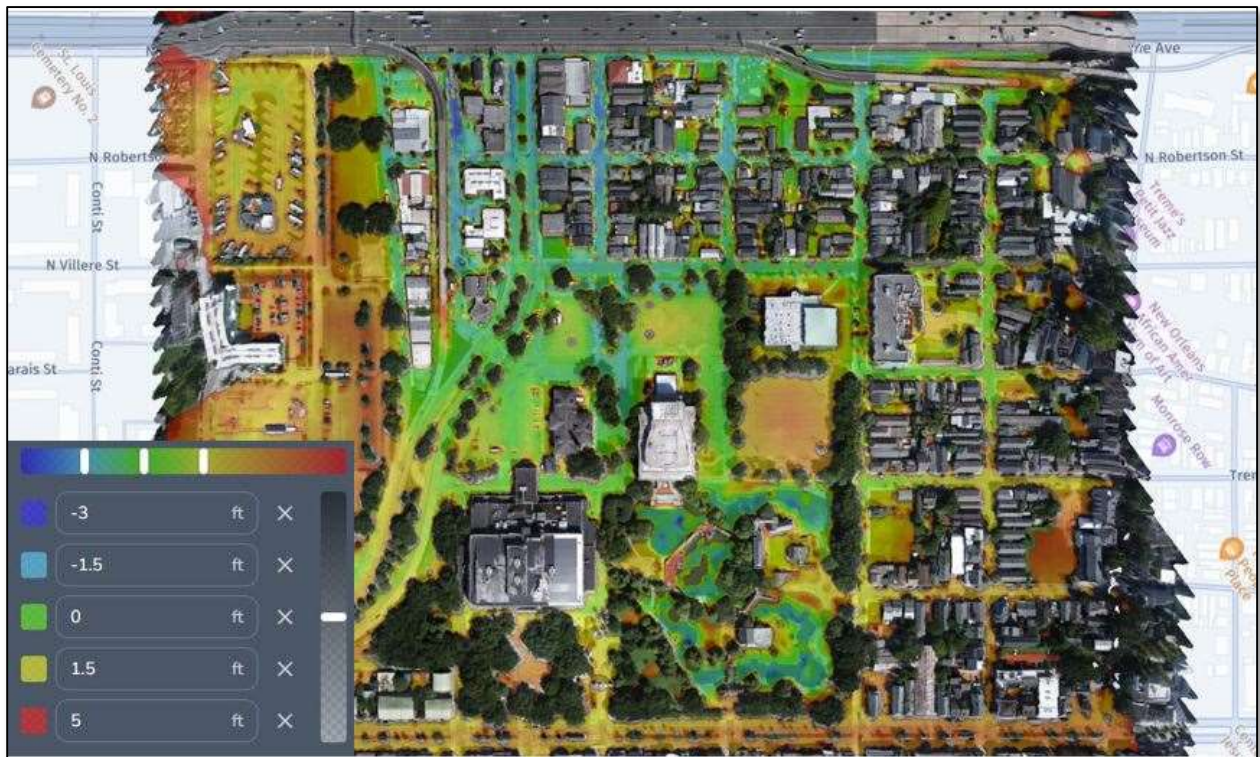
Figure 35: Topographic Elevation Heat Map – N. Claiborne to North Rampart

Figure 35 shows the elevation heat map for the area from N. Rampart to N. Claiborne. This analysis indicates that Dumaine Street, St. Ann Street, and N. Robertson Street, along with sections of N. Claiborne Avenue, are among the lowest points in this area (Area 1). These findings suggest that runoff in Area 1 originates not only from Armstrong Park, as discussed in Section 4.6, but also from St. Louis Street and the Lafitte Greenway. This reinforces the need for thorough cleaning, operational checks, and eventual capacity evaluations for these lines.

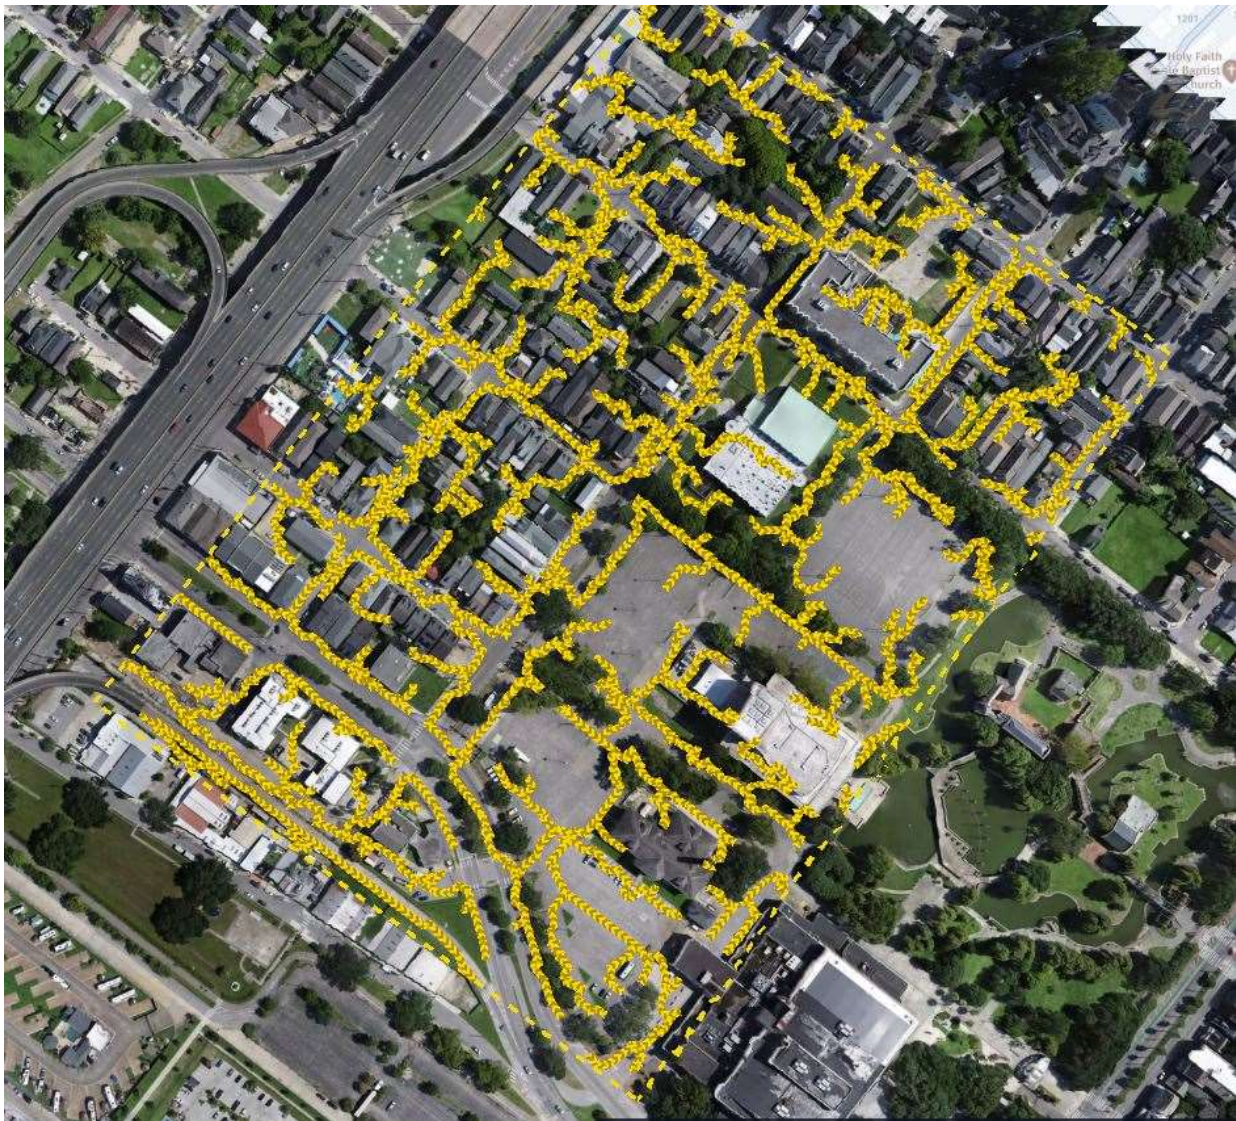
Figure 36: Flow Analysis of Areas 1 and 2

Figure 36 below illustrates modeled catchment and flow analysis derived from the drone survey for the same area shown in Figure 35. The yellow and orange arrows indicate surface flow paths, showing how rainfall moves across the landscape during storm events and where it tends to accumulate. These flow patterns confirm the location of roadway low points and validate many assumptions drawn from field visits and resident feedback.
