# Technical Memorandum

## The Seventh Ward Urban Flooding Investigation

Technical Memorandum

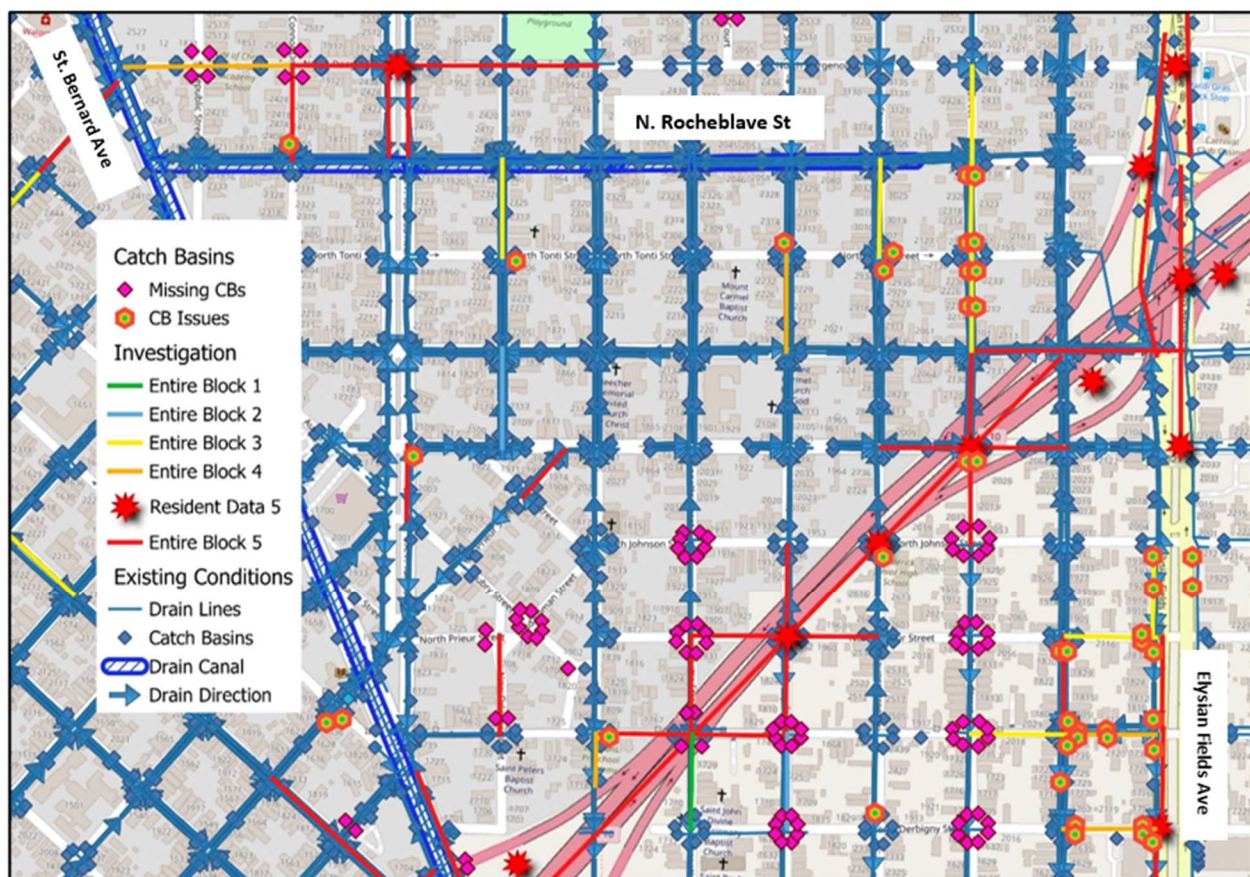
Figure 8: GIS with Resident Ratings

This rating criteria and visual approach made it easier to identify localized problem areas and compare them with topographic features, drainage infrastructure, and known system constraints. Areas with repeated high ratings often aligned with blocks lacking adequate drainage components or located at heavily lined tree areas. This GIS-integrated rating system helped prioritize areas for further field verification and guided subsequent recommendations for investigation and improvements.

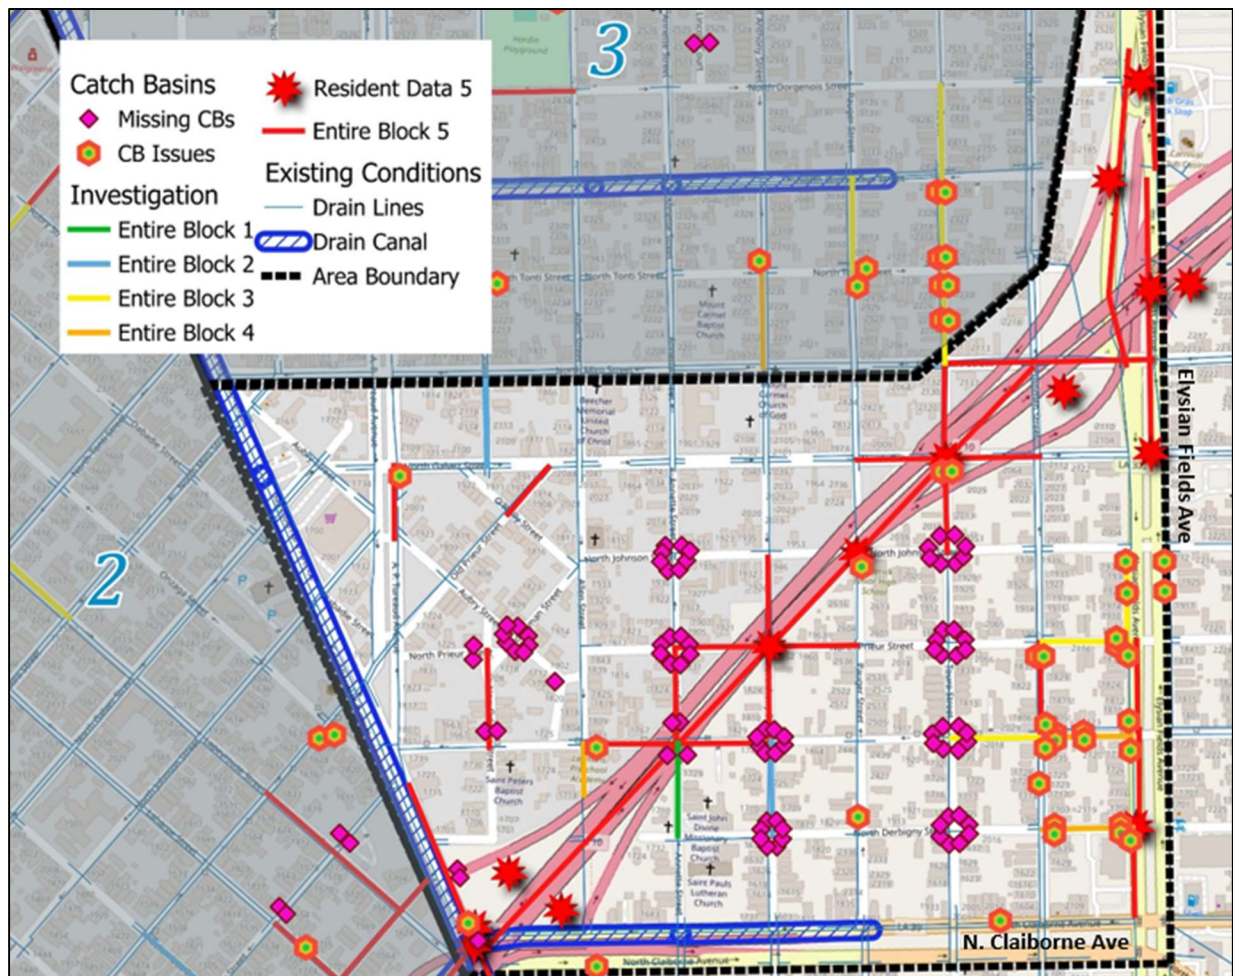
Figure 7: Neighborhood Area 1 Map

**Area 1** has three major hot spot zones characterized by impact from the I-10 overpass, insufficient draining along Esplanade Avenue, and outdated infrastructure tied to the neighborhood’s older street grid and drainage configuration. The St. Bernard canal, the N. Clairborne canal, and Esplanade Ave are the main outfall points of this area.

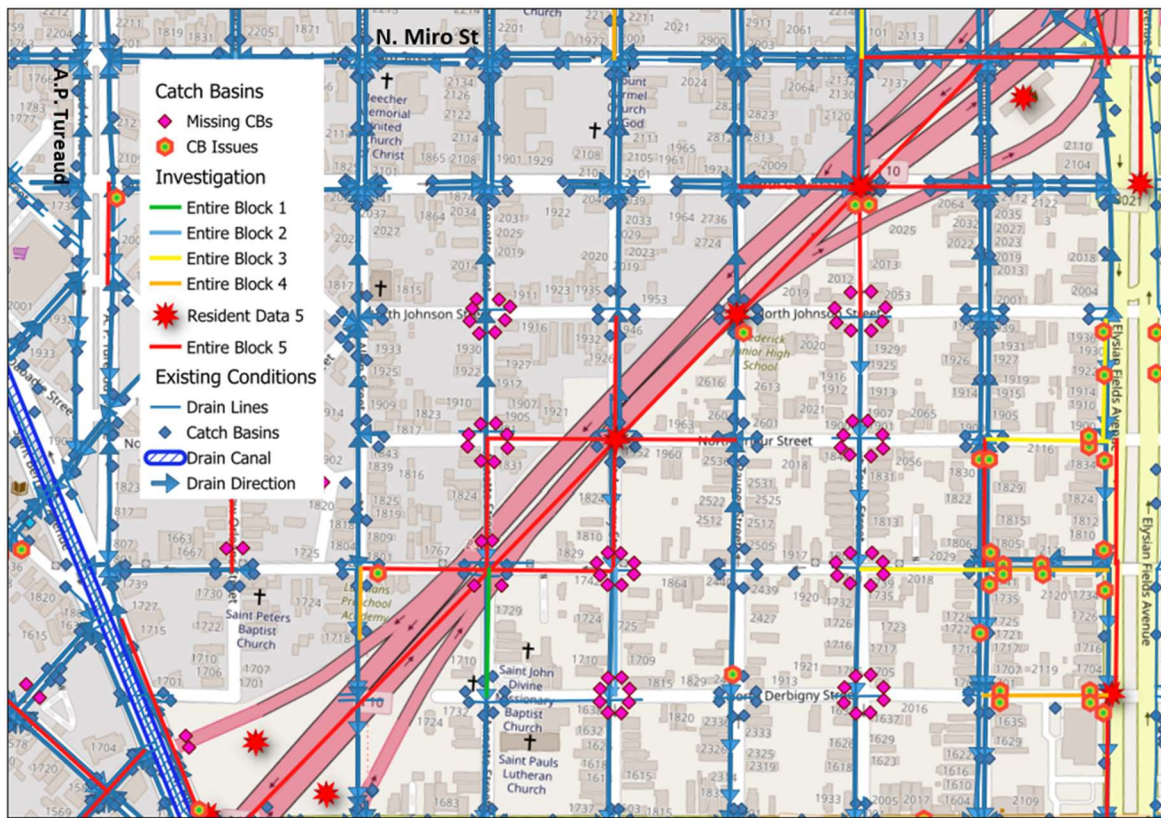
Figure 18: Map of Area 1

As shown in **Figure 18** below, flooding reports align closely with areas lacking drainage infrastructure or with reported catch basin issues.

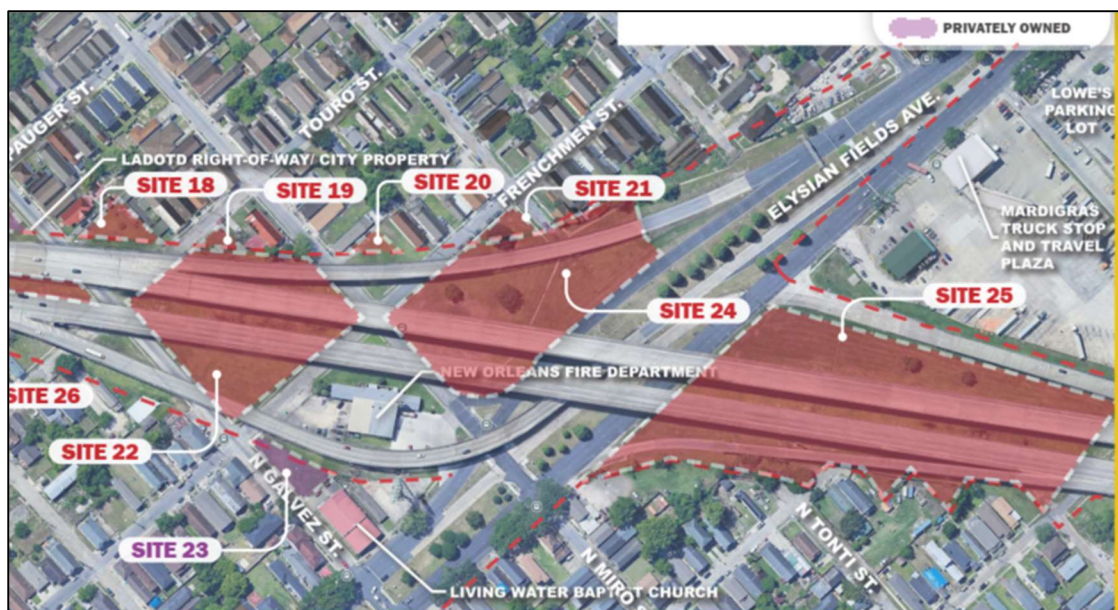
Figure 10: ASLA Numbered Sites 18-25

Sites 25, 24, and 22, between Touro Street and Marigny Street, were ranked as highest priority due to the concentration of flooding issues on Elysian Fields, along with lowest cost of implementation and no need for amenities. Potential interventions here include detention basins or trees being implemented between the bridge decks, and open space enhancements. For Site 22, ASLA recommended a dry creek between the bridge decks to help capture stormwater sheeting off the interstate, with potential for grass swale or cypress trees. Sites 24 and 25, across from Elysian Fields, for detention basins and street tree plantings. Site 25 was identified as the most expensive due to excavation and soil removal requirements. ASLA recommended that DOTD be considered as a long-term partner for annual maintenance of these areas.

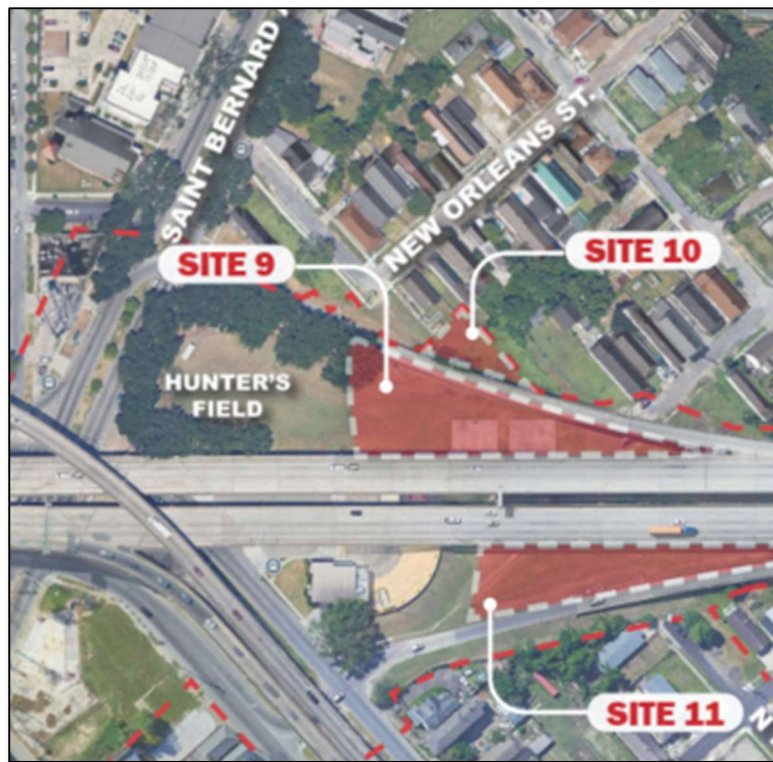
Figure 20: ASLA Numbered Sites 9-11

Another priority site was the rear of Hunter's Field (Site 9), where a medium-cost project ranked high on stormwater need and no need for amenities. Recommended interventions include a French drain leading to a detention basin at the base of the I-10 off ramp and additional street trees. This would spread stormwater management capacity across the neighborhood rather than concentrating improvements solely near Elysian Fields. Because portions of the site closest to St. Bernard Avenue are owned by DOTD, collaboration will be essential.

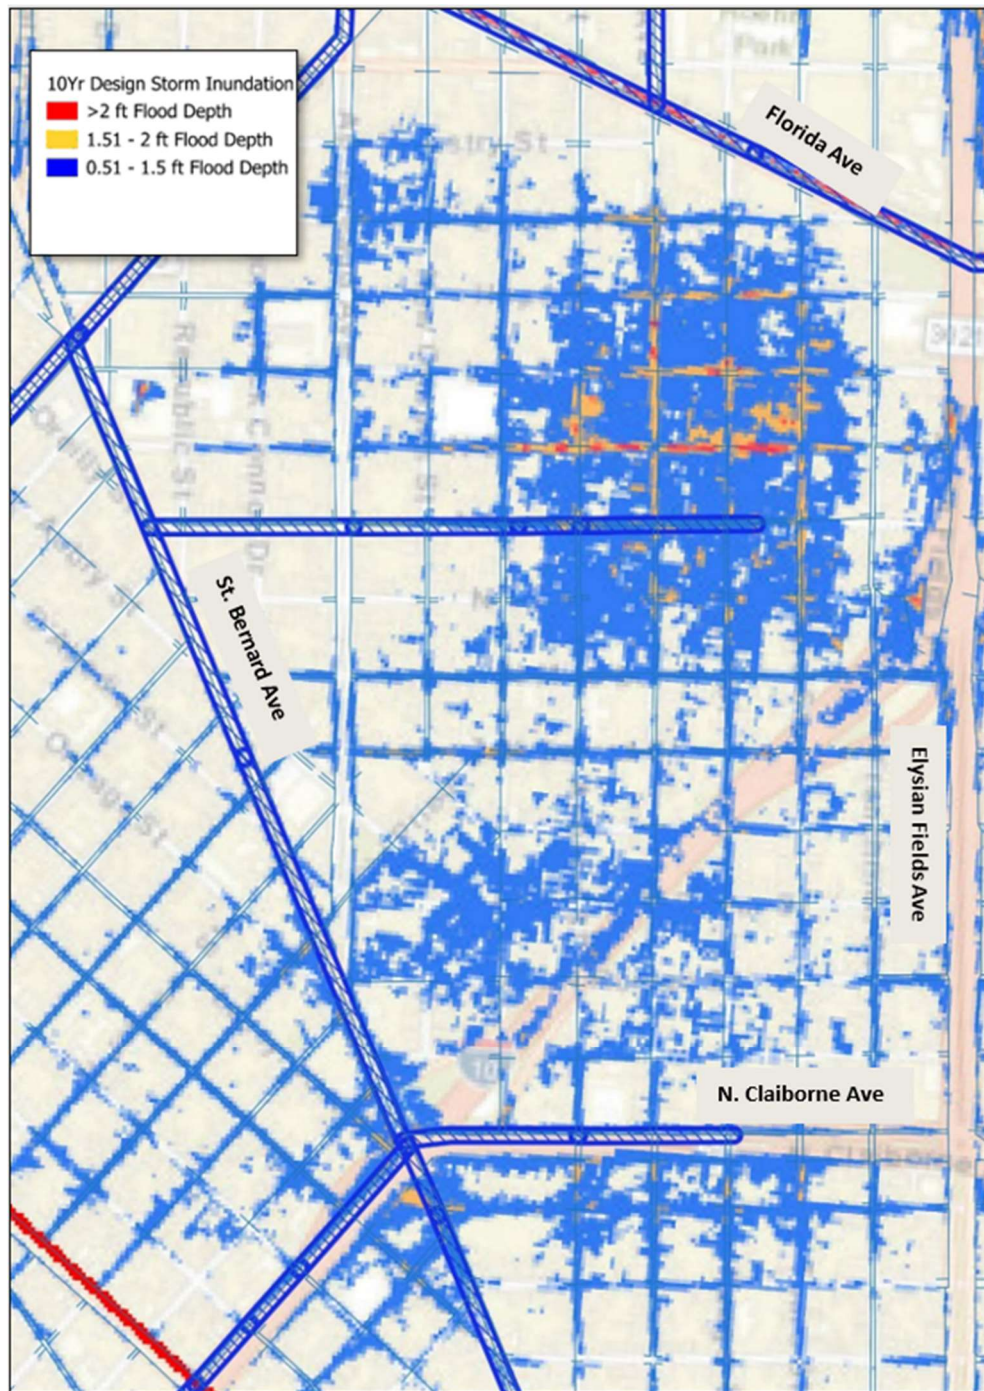
Figure 26: 10-Yr Inundation Map with Resident Ratings

Ardurra's report included design storm inundation maps for both the 10-year and 100-year storm events. **Figure 26** below shows the 10-year storm inundation map, which highlights the theoretical expected flooding depths across the neighborhood. The most notable high-inundation zones occurred in Area 3 and along the I-10 corridor.

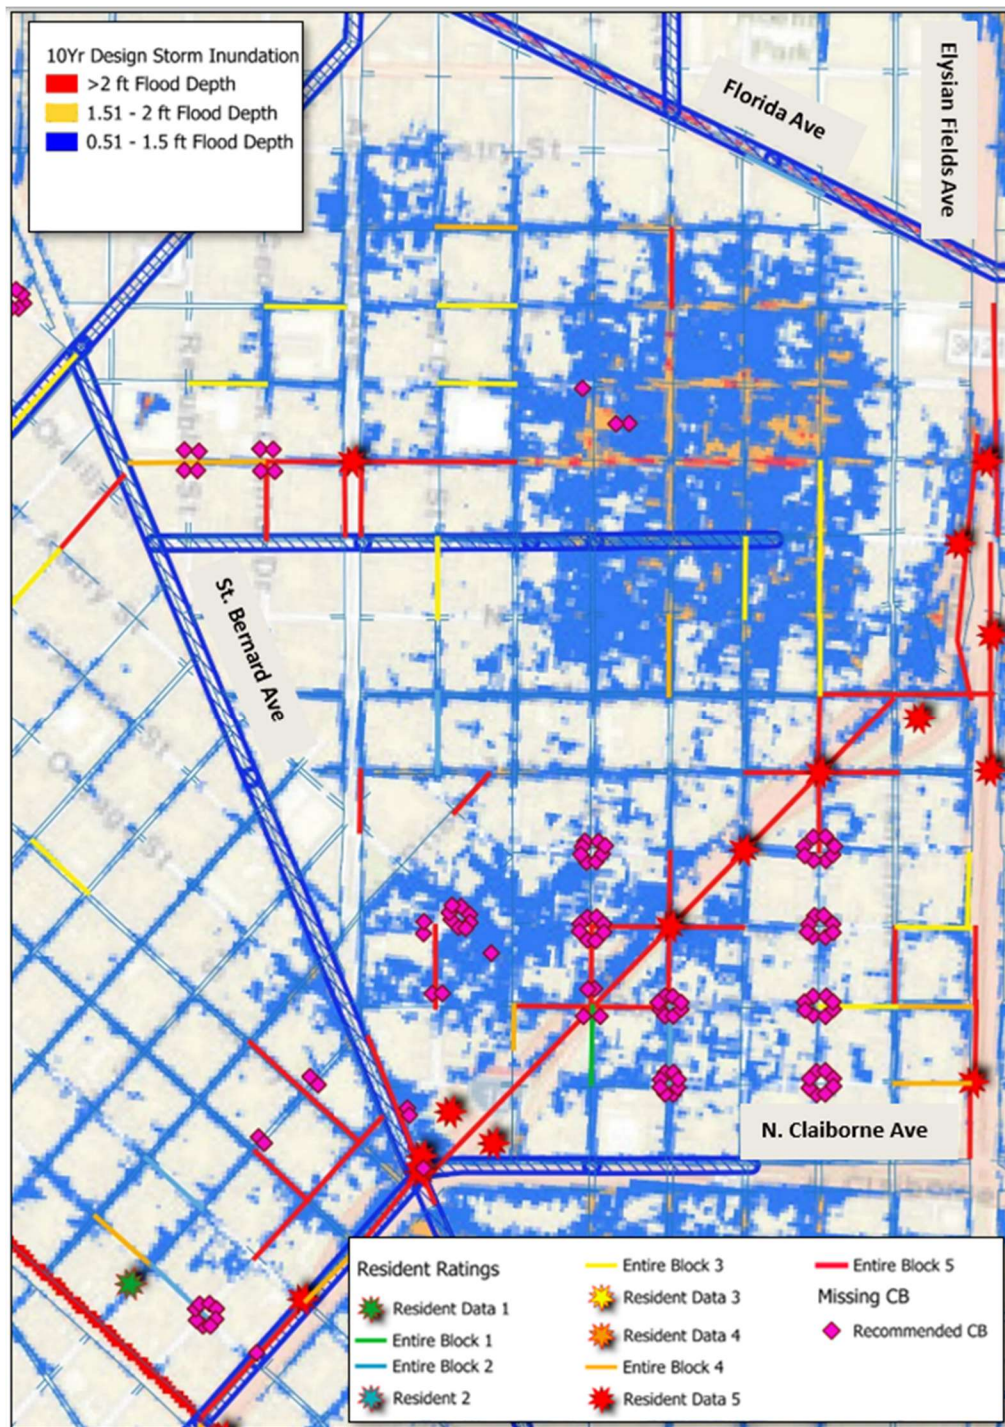
Figure 27: 10-Yr Inundation Map with Resident Ratings

When overlaid with our resident ratings database, the modeled patterns showed both alignment and differed. The Ardurra model highlights the upper right quadrant of the neighborhood as susceptible to flooding during a 10-year storm, yet resident reports and field investigations did not identify this as a current problem area. Additionally, there exist several locations not identified in the model but clearly experiencing drainage failures on the ground, like that west of St. Bernard Ave. These comparisons demonstrate that while the models capture long-term risks tied to undersized infrastructure, they do not fully reflect the real-world flooding that occurs during more frequent, smaller storms.

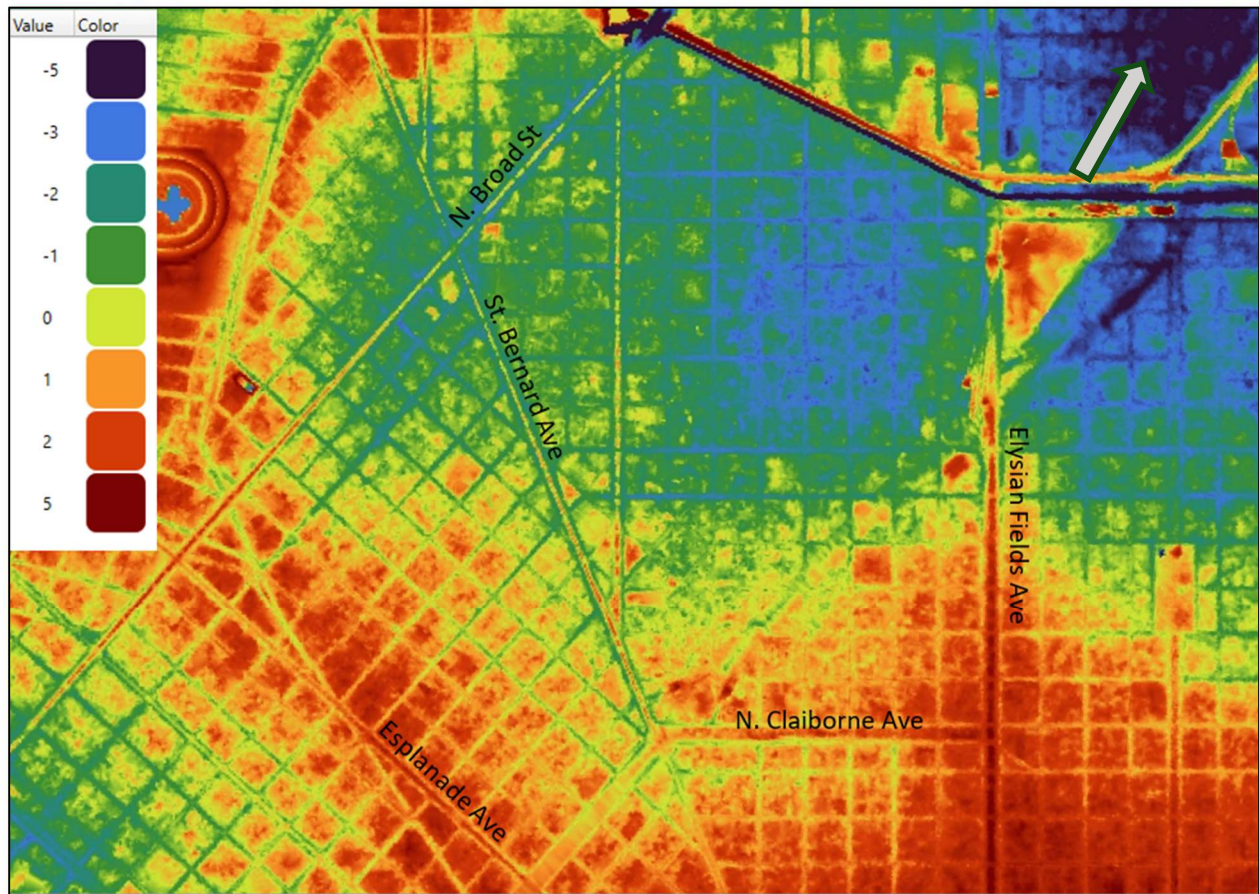
Figure 28: Topographic Elevation Map of the Seventh Ward

**Figure 28** presents a topographic heat map of the investigation area, illustrating relative surface elevations throughout the neighborhood. Blue and green tones indicate the lowest points (-1 to -5 feet), while yellow through red represent higher elevations (0 to +5 feet). Consistent with field observations, high points were identified along Esplanade Avenue, N. Claiborne Avenue, and Elysian Fields Avenue. The lowest elevations occur in the upper right quadrant of the neighborhood, where grades drop below -3 feet. This pattern suggests that stormwater generally flows from the higher perimeter streets toward the lower-lying interior blocks, especially in areas where catch basins may be clogged or underperforming. This reinforces the need for a well-maintained drainage system throughout the area, especially in low points where flow concentrates.

The LiDAR surface also shows that elevations are higher toward the French Quarter at the southern edge of the neighborhood, while areas northeast past the Seventh Ward sit lower than the surrounding areas. Interestingly, the lowest elevations do not closely align with areas most frequently reported by residents as flood-prone, indicating that the drainage issues extend beyond topography alone. In many cases, blocked catch basins, heavy oak tree debris, and poor subsurface connectivity appear to be primary contributors to standing water. The low points identified by the LiDAR map remain important indicators of where maintenance should be prioritized to ensure runoff from higher surrounding blocks can be effectively conveyed, and help evaluate where future catch basins implementation might be optimally placed to collect runoff.
